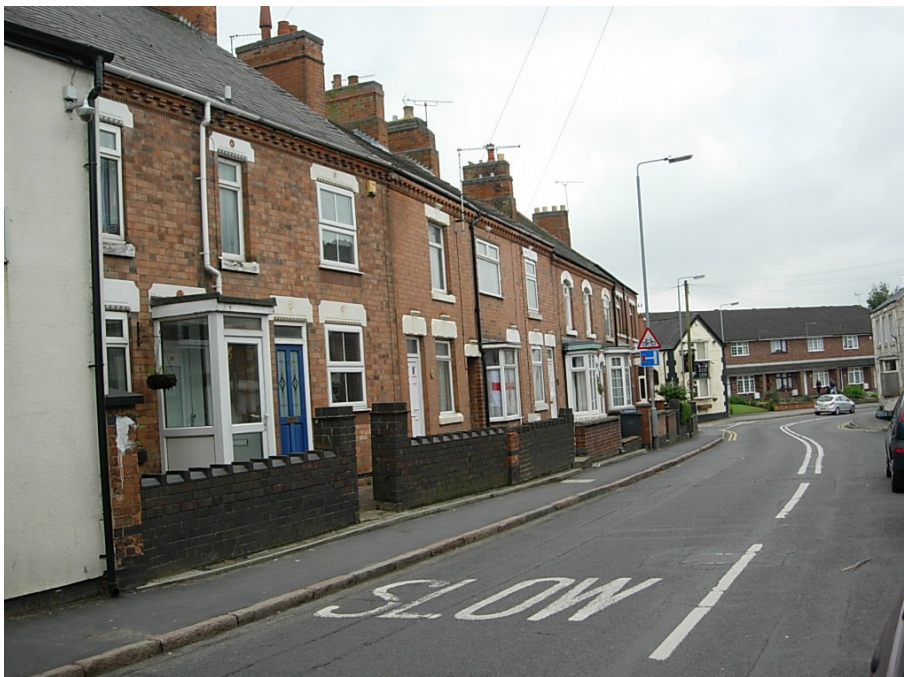
A consistent approach to the garden walls of this terrace would improve its appearance. The modern porch is also out of character.

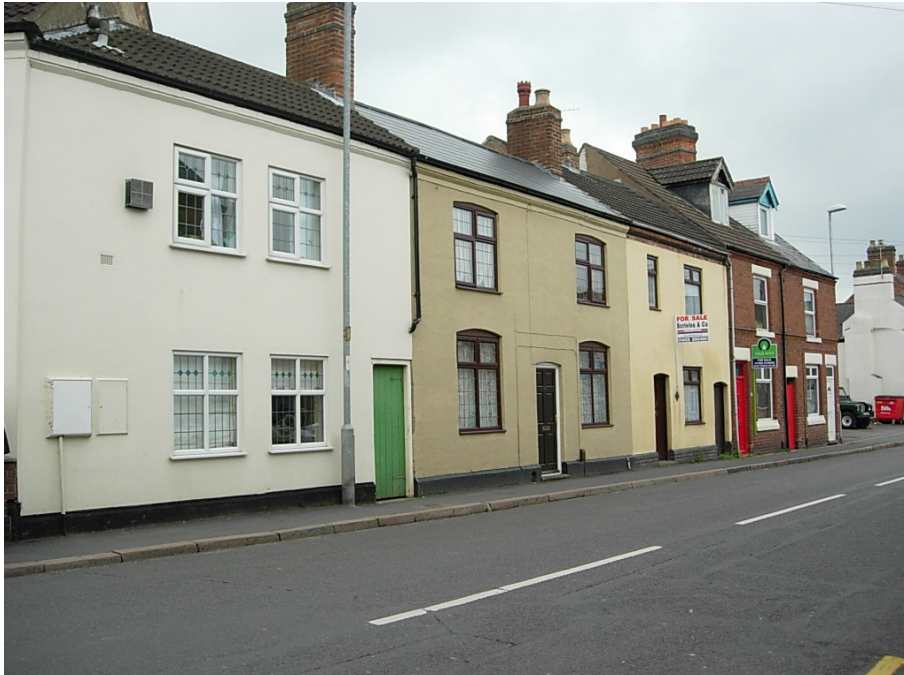
The two dormers on this terrace are out of character with other properties in the street. A more consistent roof material would also improve the terrace's appearance.

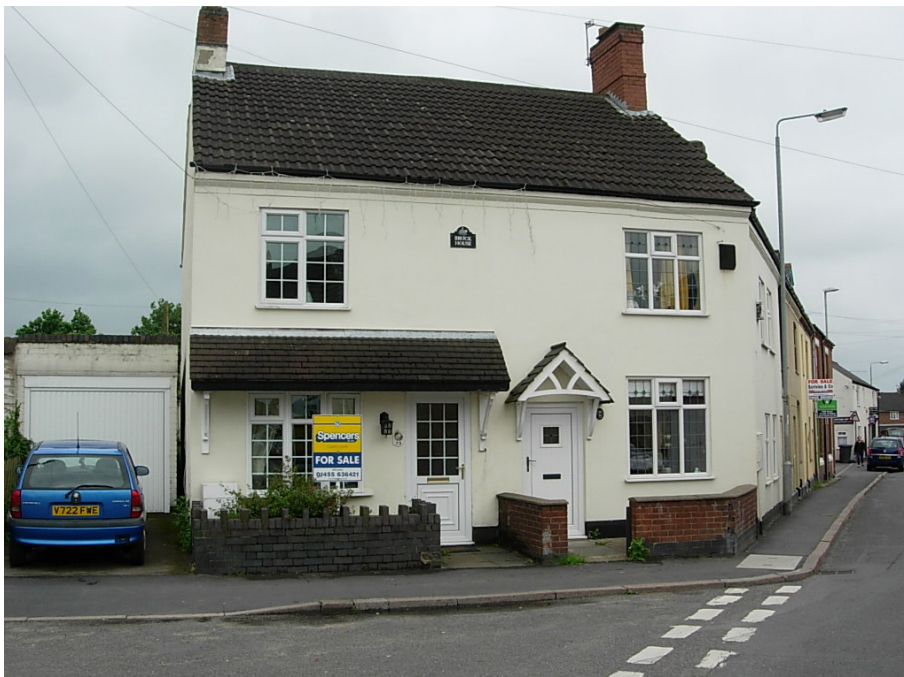
These two properties at the junction of High Street and Church Lane would be improved if traditional materials had been used in their modernisation.

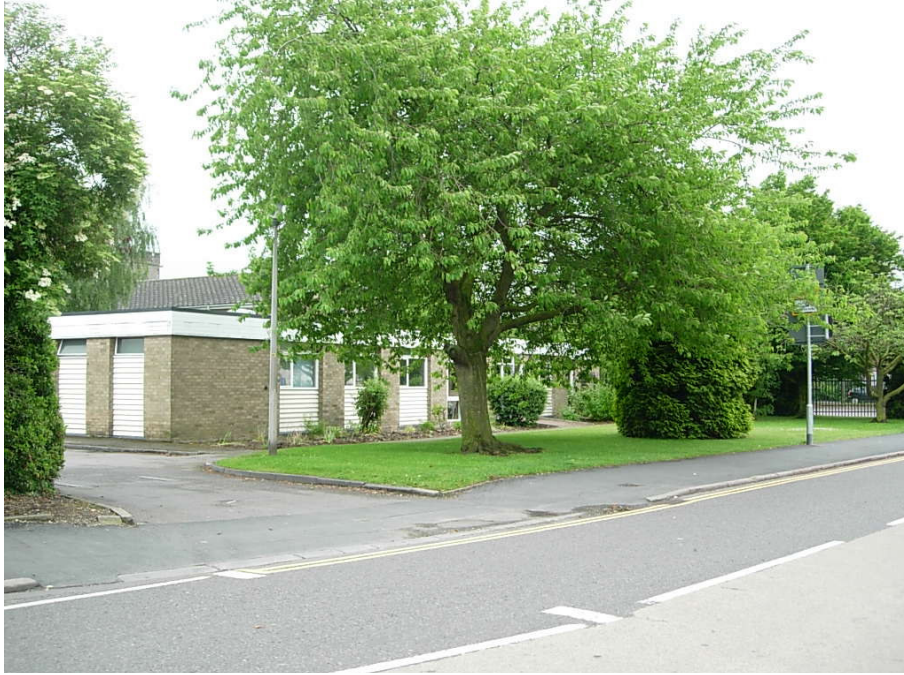
The planting at the junction of Church Lane and the High Street is an important landscape feature. The provision of fencing along the frontage would provide a clearly defined boundary

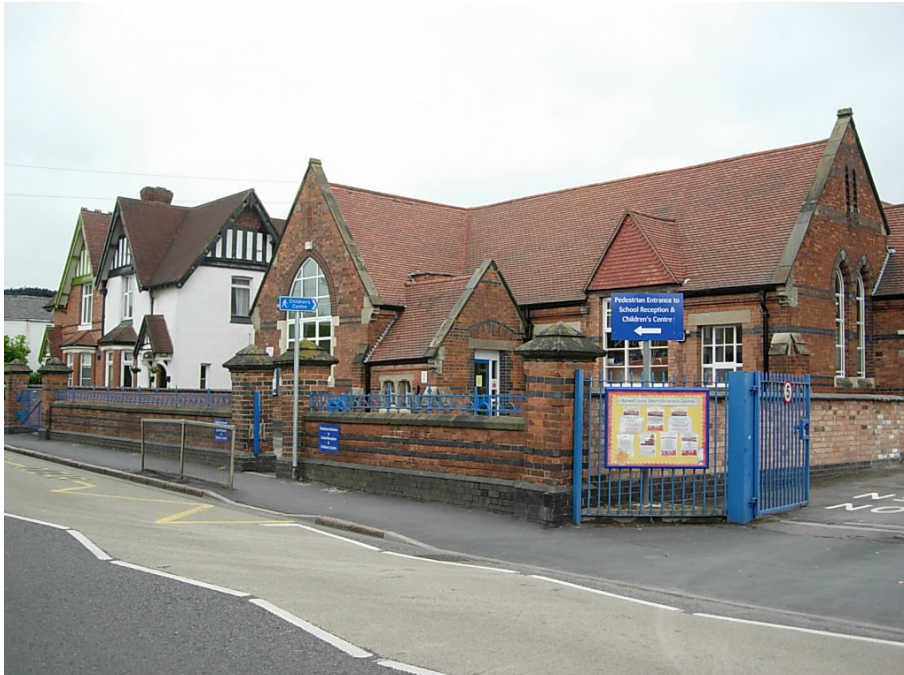
The school is a major landmark building on High Street. The replacement plastic windows has had a detrimental impact on the traditional character of the building.

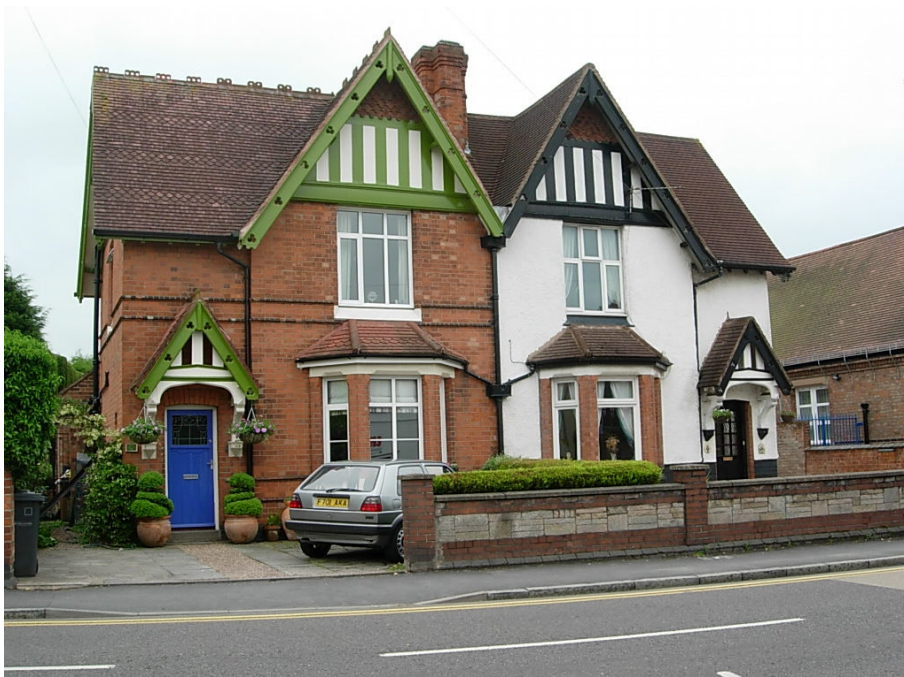
This fine house is very well maintained and has improved this part of the conservation area. The adjacent property has unfortunately lost some of its original features.

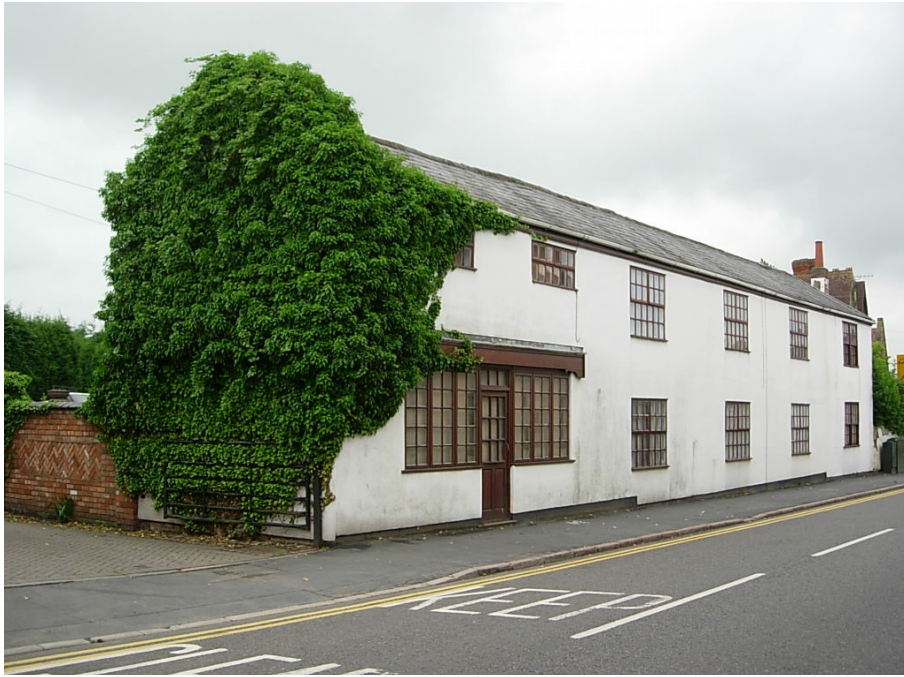
This building and its rear yard was formerly known as Jiggy Green's farm. The property is in need of maintenance.

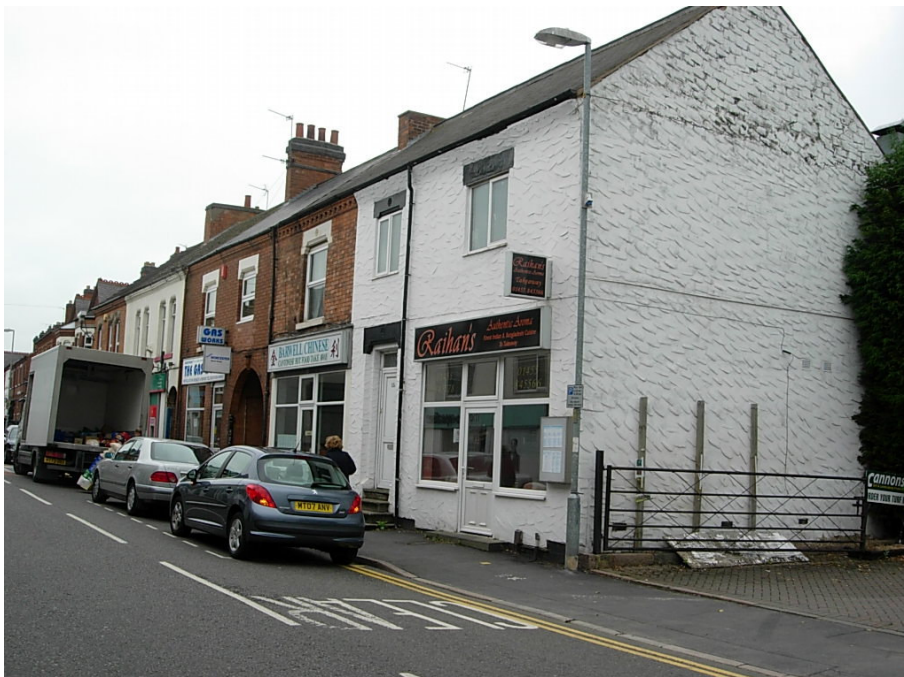
The style of rendering used on the gable of this property detracts from its appearance.

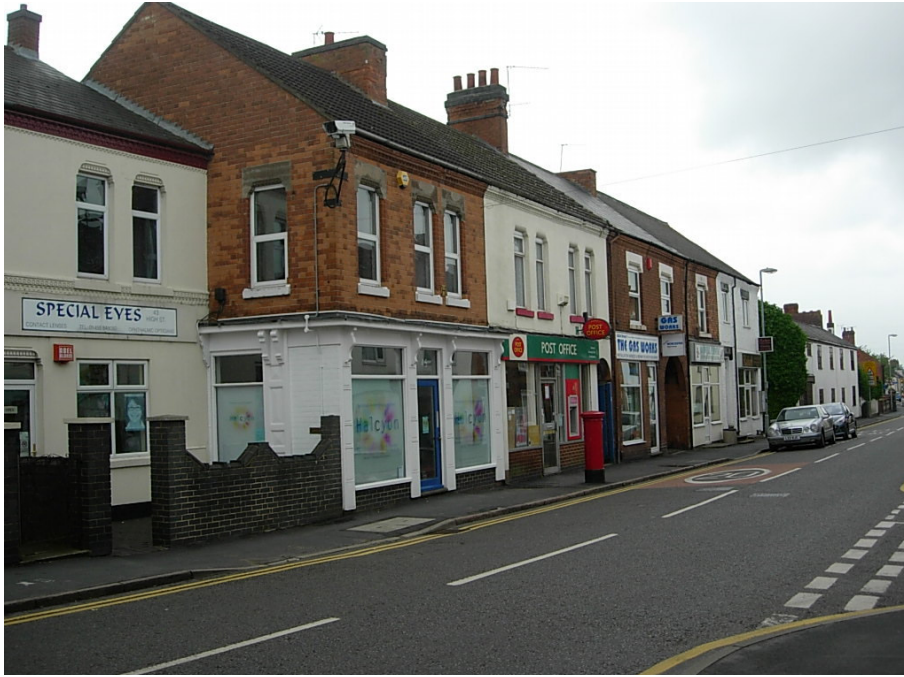
Several shop fronts in the conservation area would benefit from the adoption of traditional designs and materials.

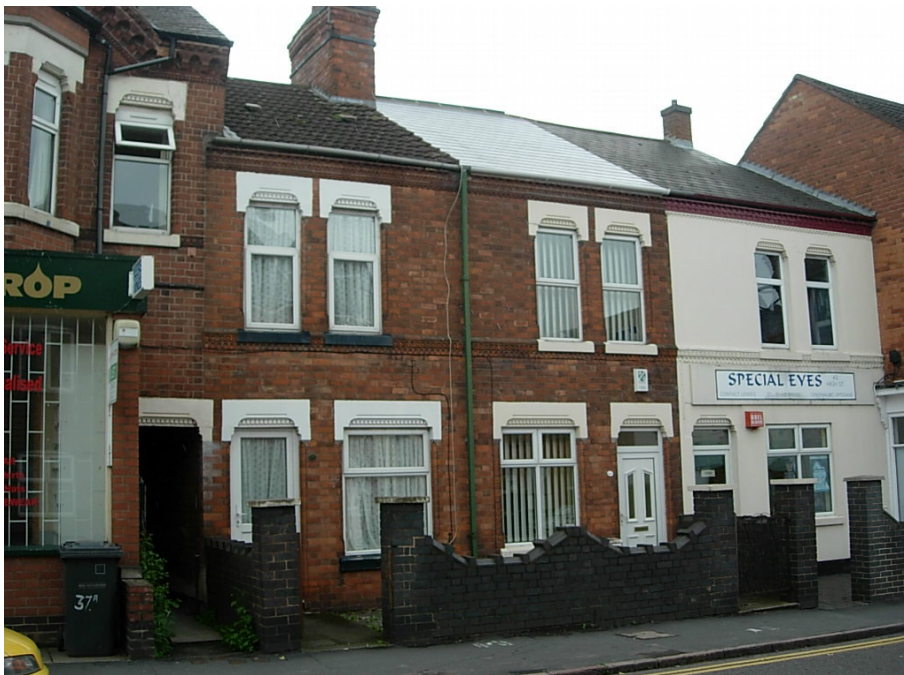
The appearance of the roofs of this short terrace would be significantly improved if a consistent natural material had been used.

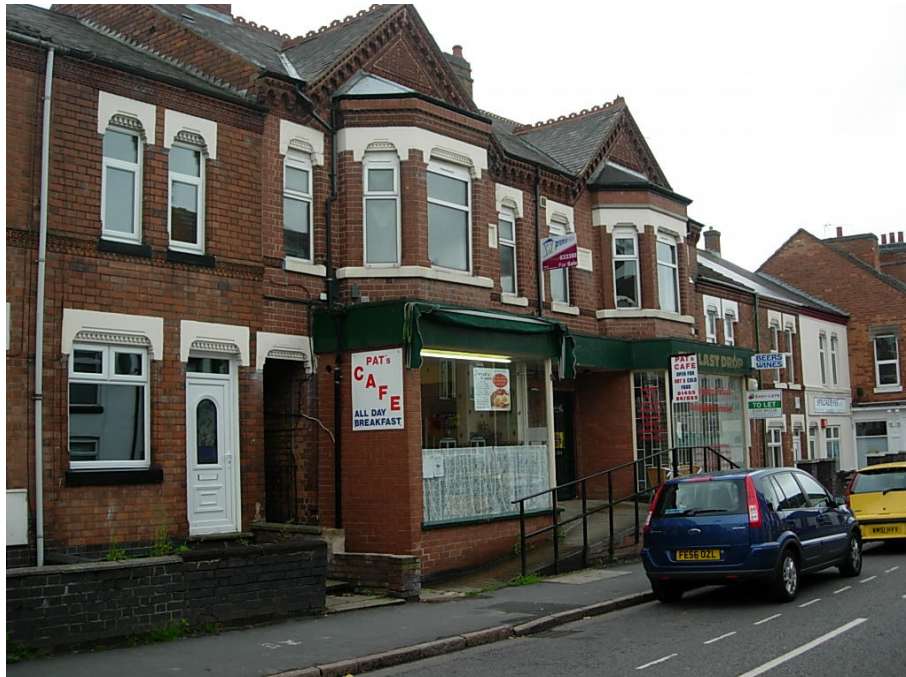
The traditional character of 35-37 High Street, built 1891, has large bay windows at first floor level and attractive decorative gables. The properties have been spoilt in the past by the introduction of projecting shop fronts which have a detrimental impact on the street scene as a whole.

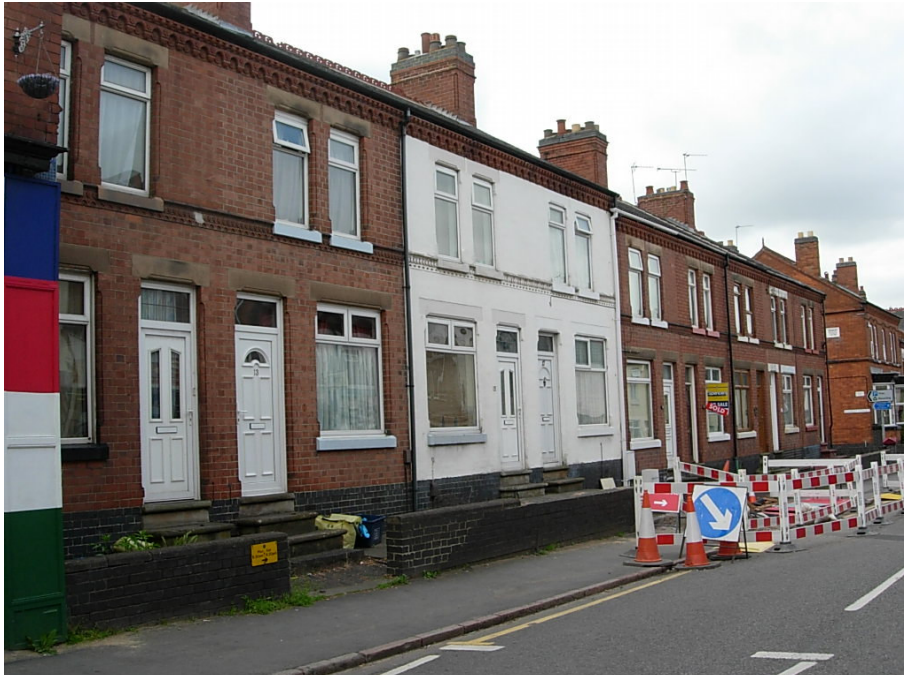
This terrace would be improved if the short front gardens were hard surfaced and a consistent approach adopted for the garden wall construction.

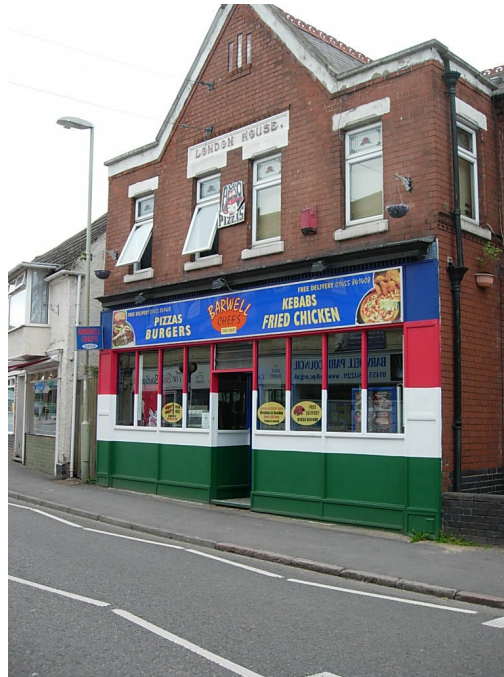
The over dominant signage, multi-coloured frontage and roller shutter on London House has a detrimental impact on its appearance.

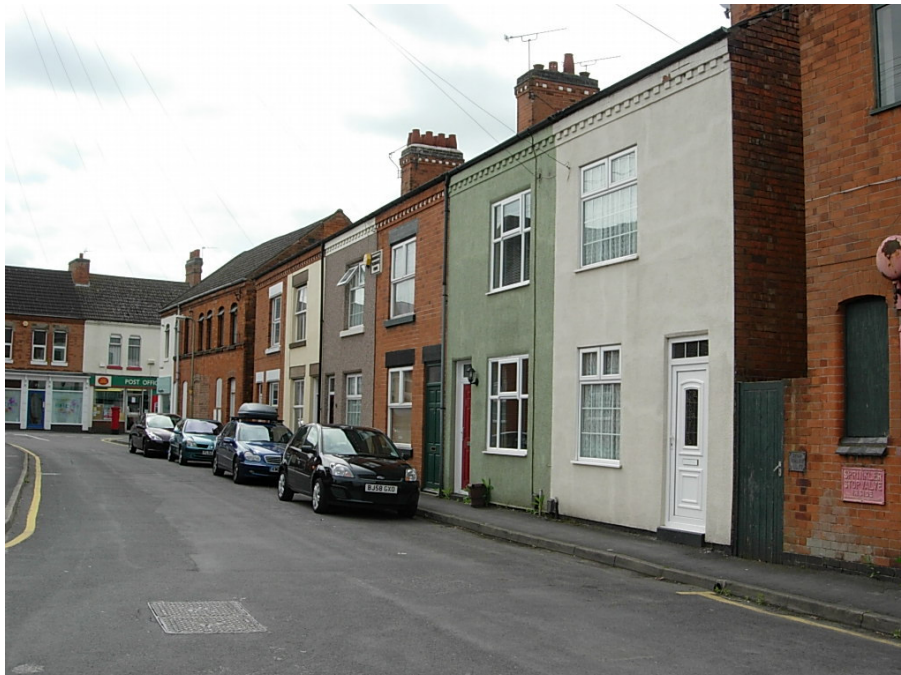
The unity of 1-11 The Barracks is lost by the multi-coloured rendering and re-constructed window openings. The properties still retain their original imposing chimneys and several stone window lintels.

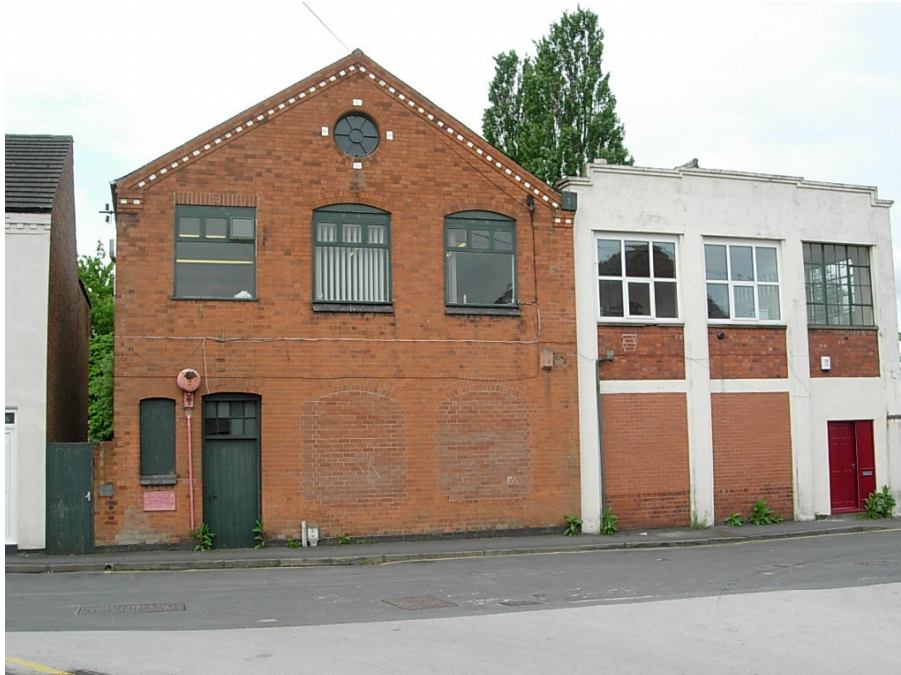
This fine former Victorian boot & shoe factory at the lower end of The Barracks was extended in 1930. Unfortunately the original windows have been replaced and two ground floor openings bricked up.

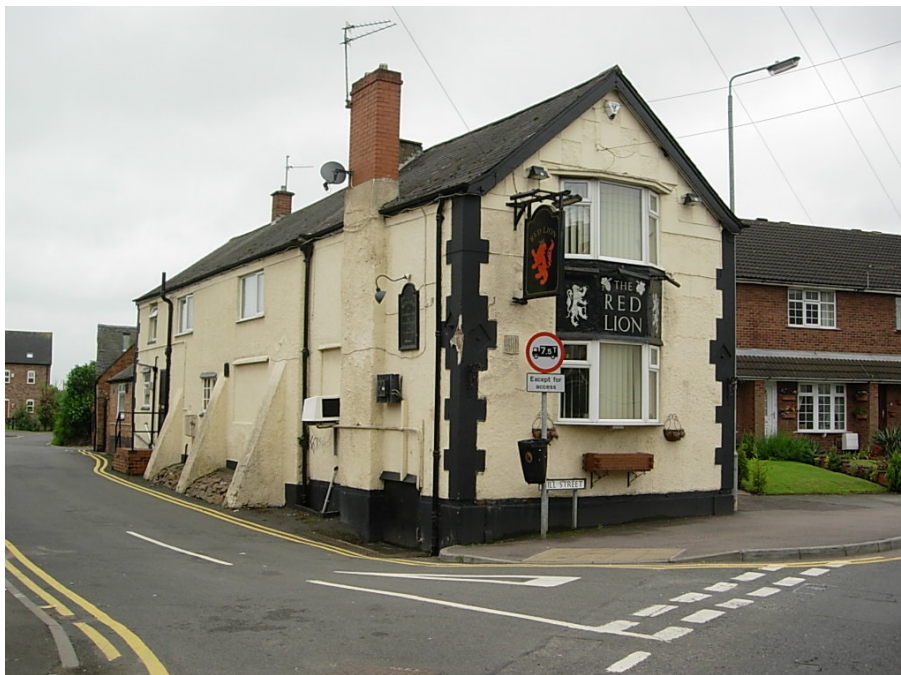
The Red Lion Pub, sited at the junction of High Street & Mill Street, is a striking rendered building that unfortunately has had its chimney stacks re-built.

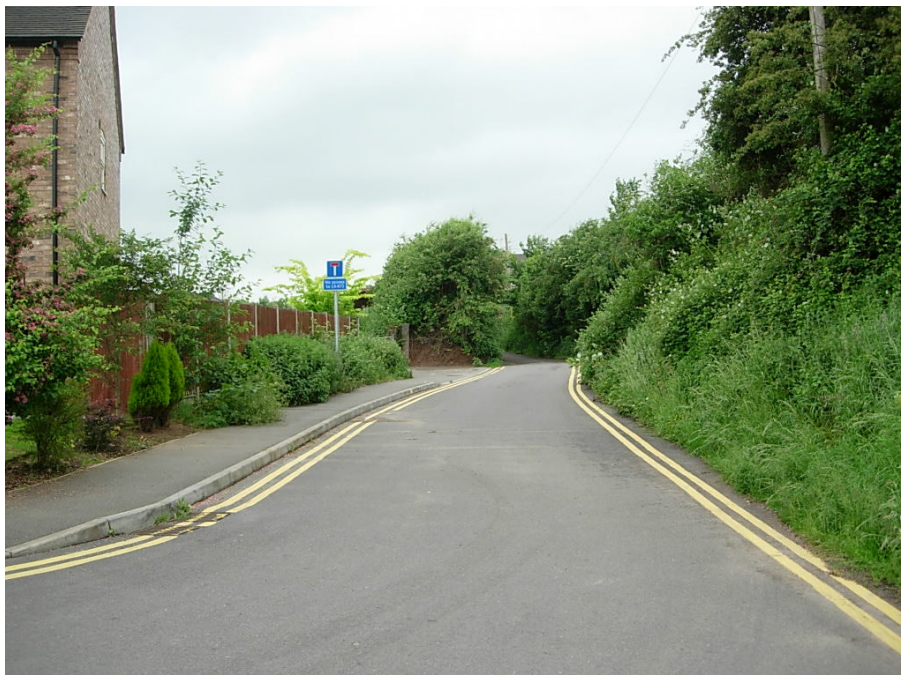
View along Barwell Lane towards the countryside. Unfortunately, the yellow no parking lines have given the lane an urban appearance.

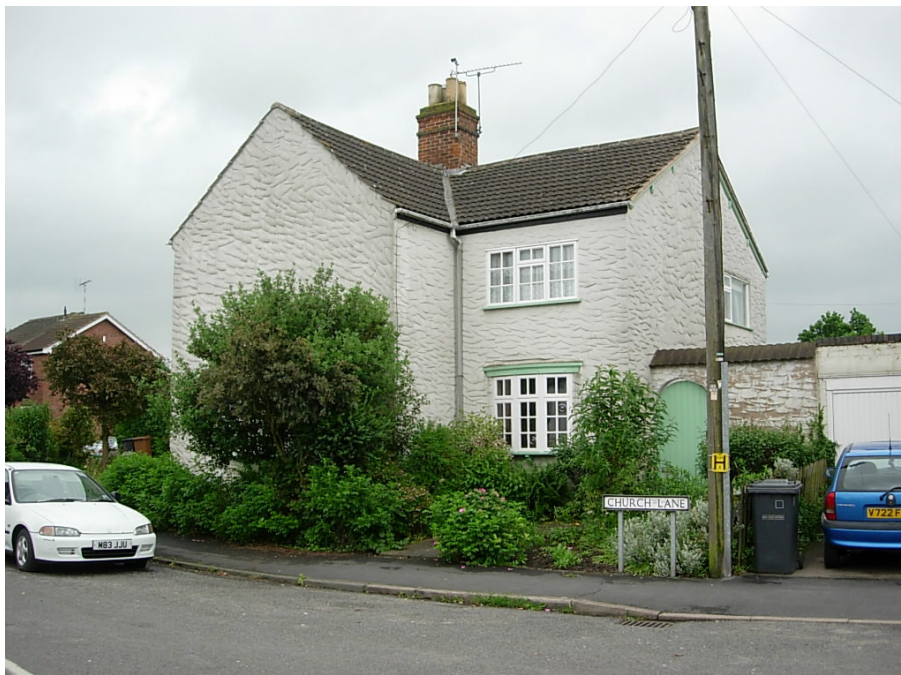
The property, 3 Church Lane, has lost most of its traditional character due to the modernisation of its windows and roof and inappropriate style of render.

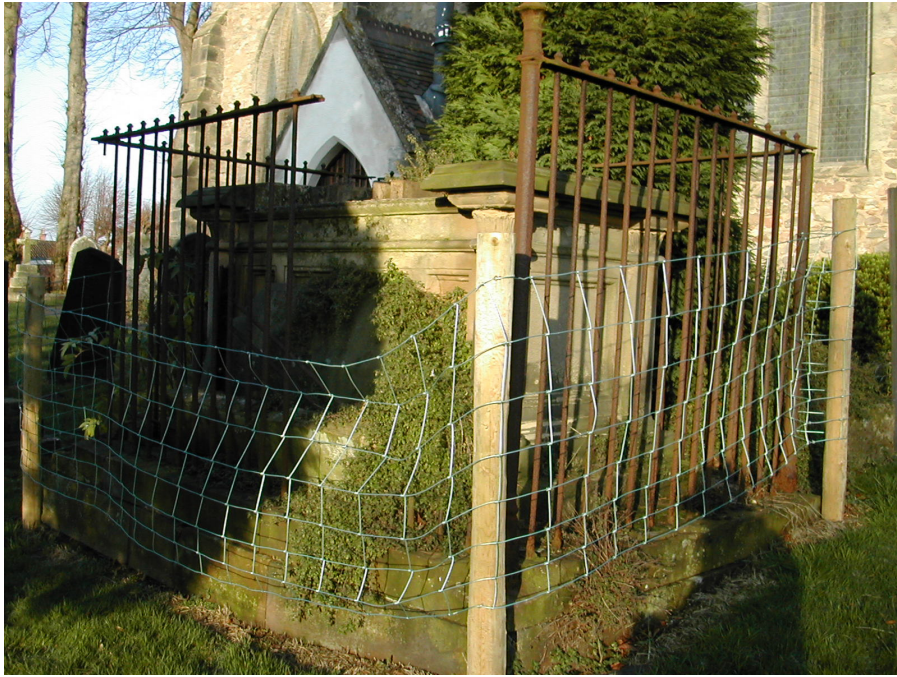
The chest tomb sited in the parish churchyard was in a dangerous condition and fenced off. The Borough Council has recently restored the tomb and railings.

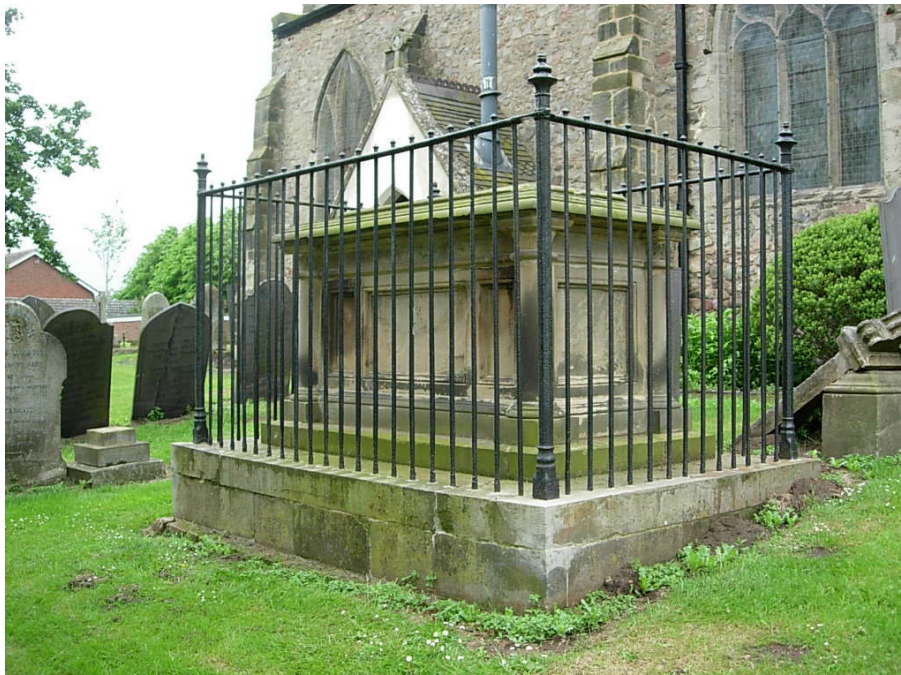
The chest tomb today. These tombs are important historic and architectural features that will be lost to future generations unless they are restored.

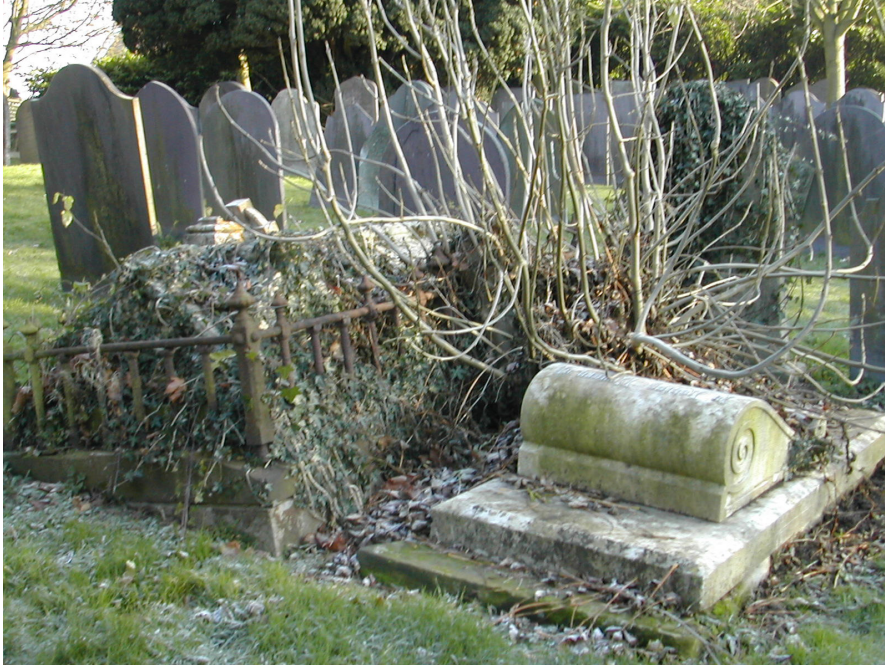
Another churchyard tomb before its restoration.

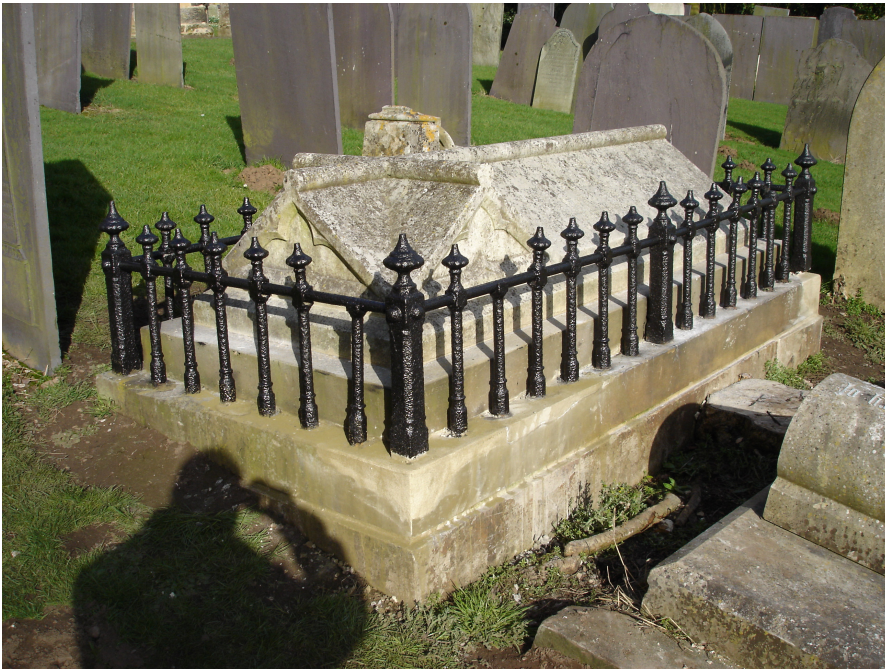
The tomb and cast iron railings after restoration by the Borough Council.
