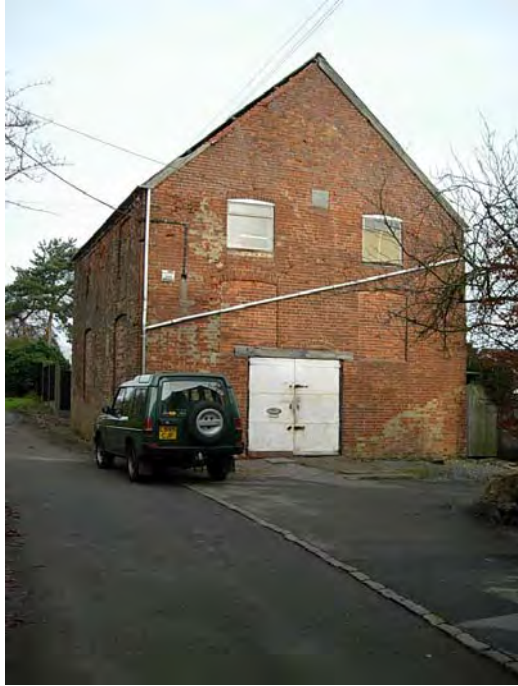
The former Methodist Chapel built 1811. Although the property's interior has been cleared and is now used for car repairs, the shell of the building is still of considerable visual and historical importance at the northern end of The Green.

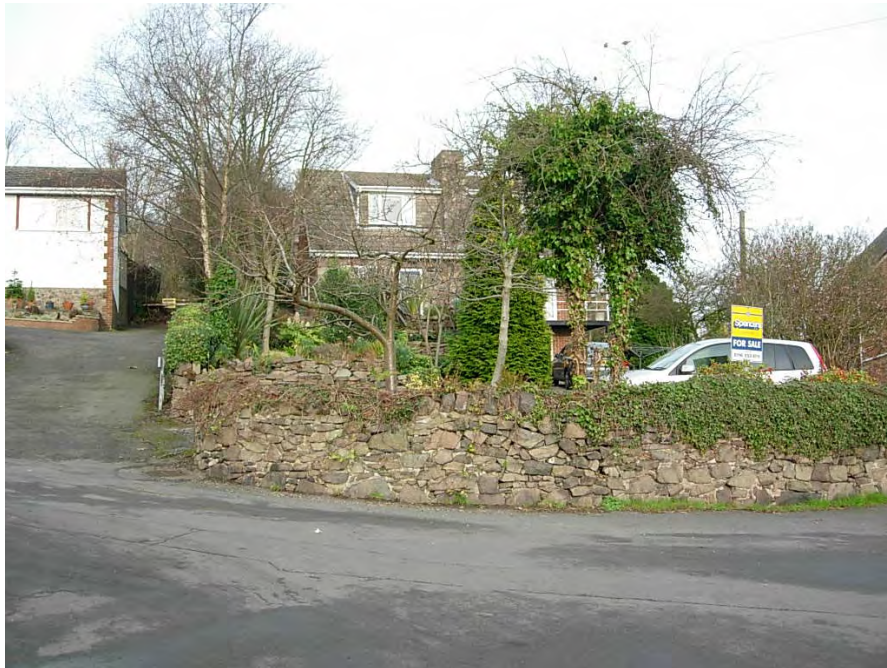
This dormer bungalow at 61 The Green does not reflect the traditional character of the village, although it does have a good stone wall running around its cartilage.
