GROBY CONSERVATION AREA APPRAISAL & MANAGEMENT PLAN

**PHOTOGRAPHIC SURVEY OF
GROBY CONSERVATION AREA**

November 2010

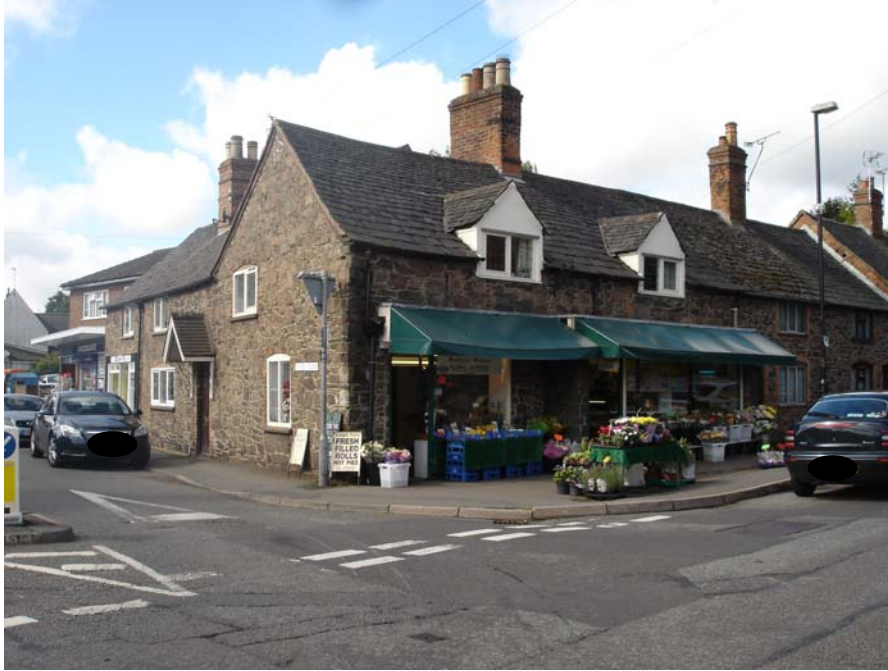
1 Markfield Road sited at the junction with Ratby Road is a pleasant stone property. Unfortunately, the two dormer windows and fixed plastic shop canopies are not traditional features within the conservation area. The chimney stacks and pots are imposing features in this area of the conservation area.

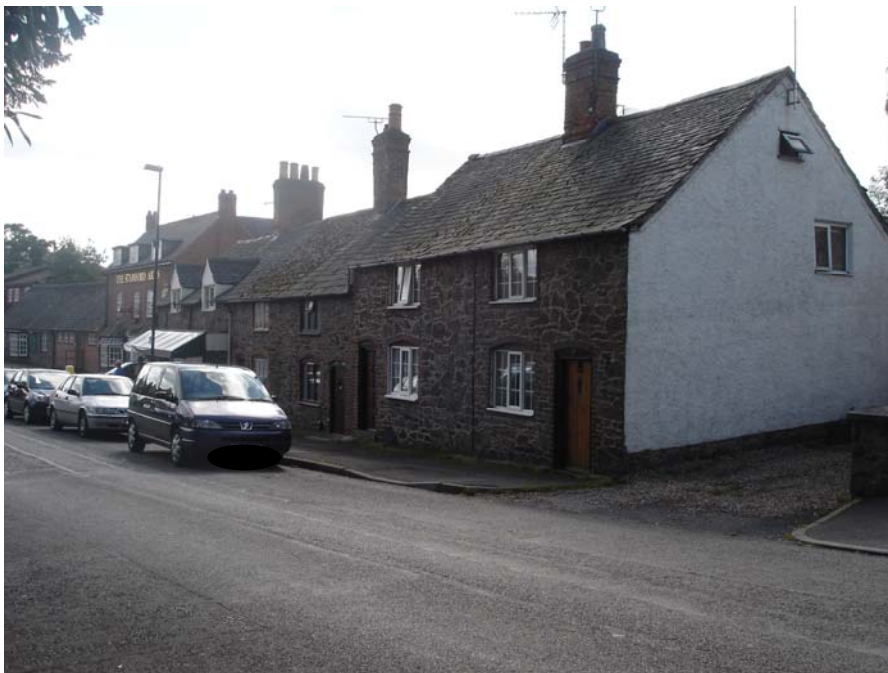
The terrace of four dwellings 3 – 9 Markfield Road are stone properties with slate roofs and dominant chimney stacks. Unfortunately, the gable end to no. 9 has been rendered.

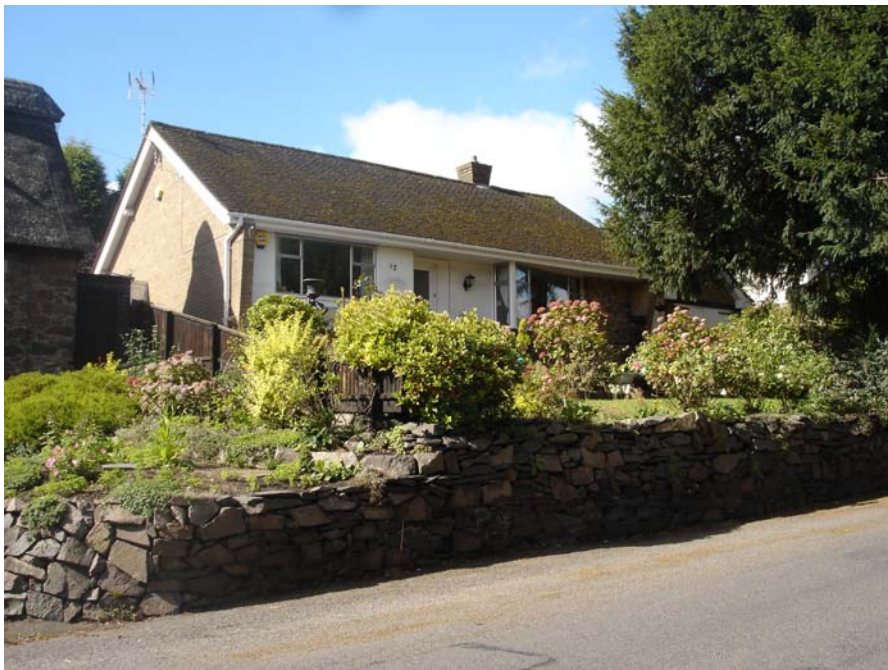
This bungalow is one of three modern dwellings that run up Markfield Road numbering 17 – 21. Unfortunately, these dwellings do not respect the traditional character of the conservation area by way of their design or use of modern materials.

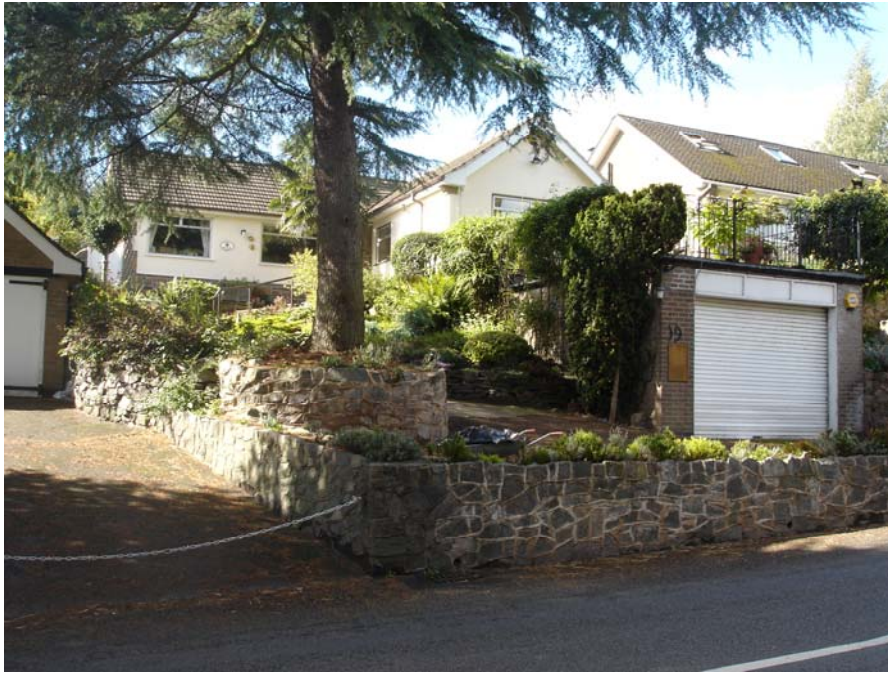
The brick garage fronting 19 Markfield Road does not respect traditional character of the conservation area in its form or siting.

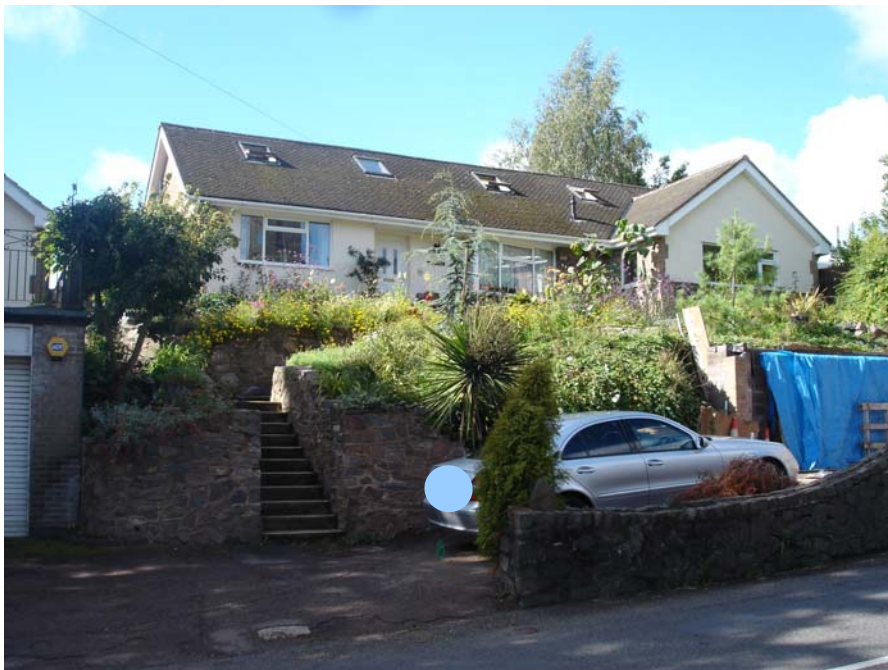
The modern bungalow, 21 Markfield Road, does not reflect the character of the conservation area.

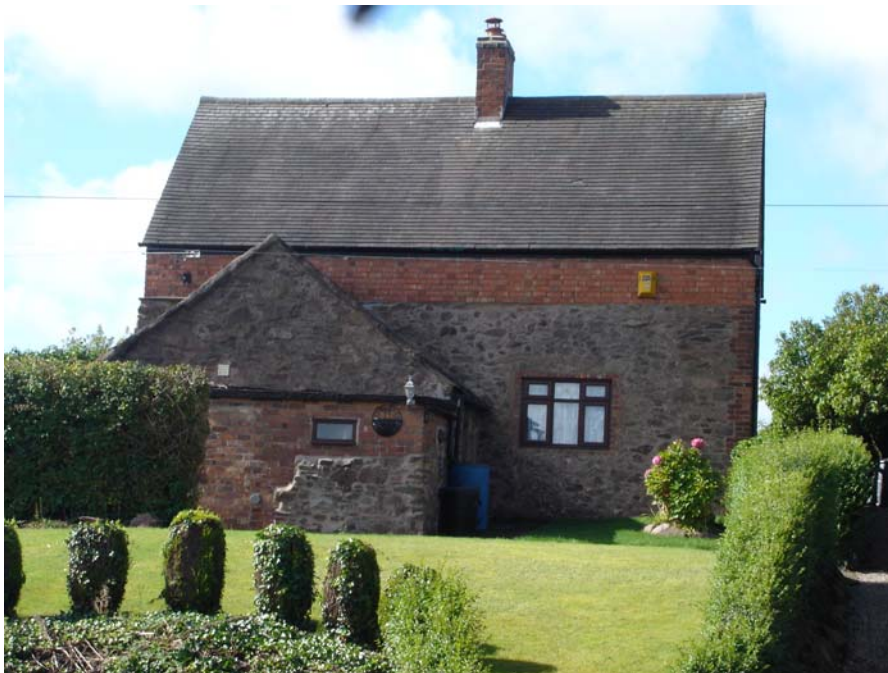
The stone property, 33 Markfield Road, showing its roof has been raised in brick and re-roofed with clay tiles.

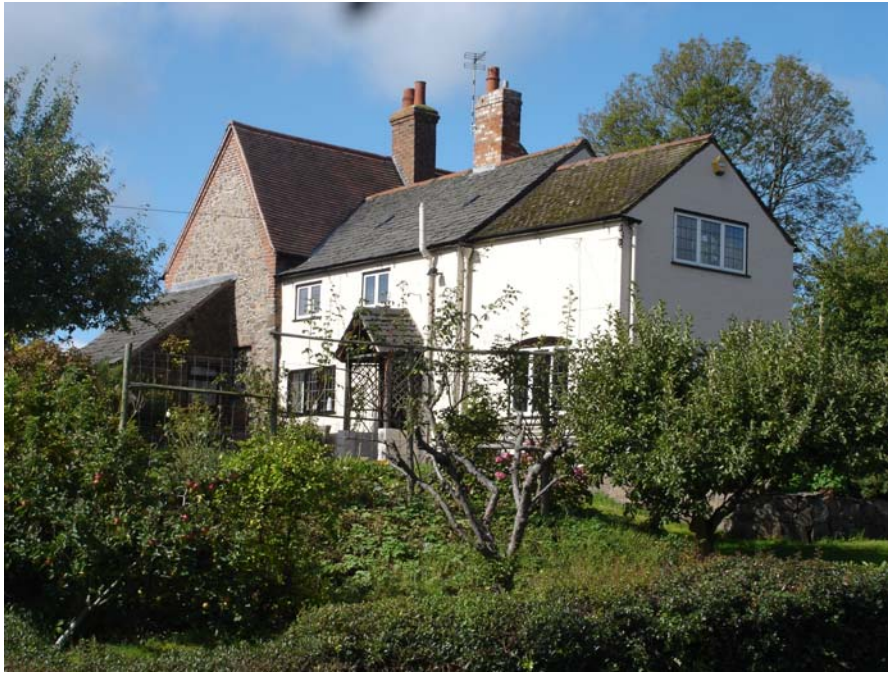
Both 35 & 39 occupy an elevated position on Markfield Road. Number 35 has a slate roof and has been modernised with a brick extension built on its front elevation painted white with plastic windows installed. The property, 39 Markfield Road, is sited to the rear with a large stone gable and roof tiles.

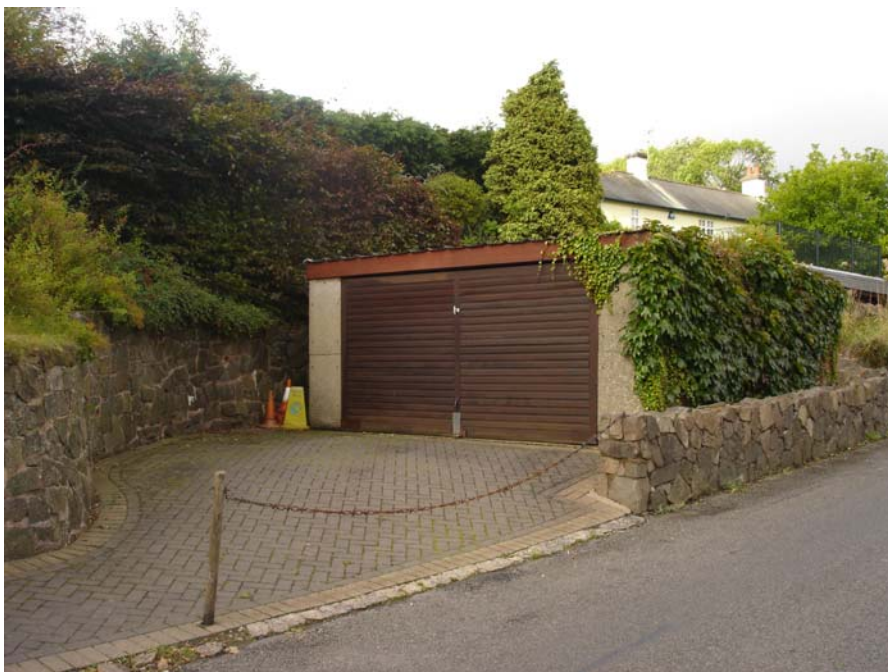
This pre-cast concrete sectional garage fronting 35 Markfield Road is a particularly unattractive building in the conservation area.

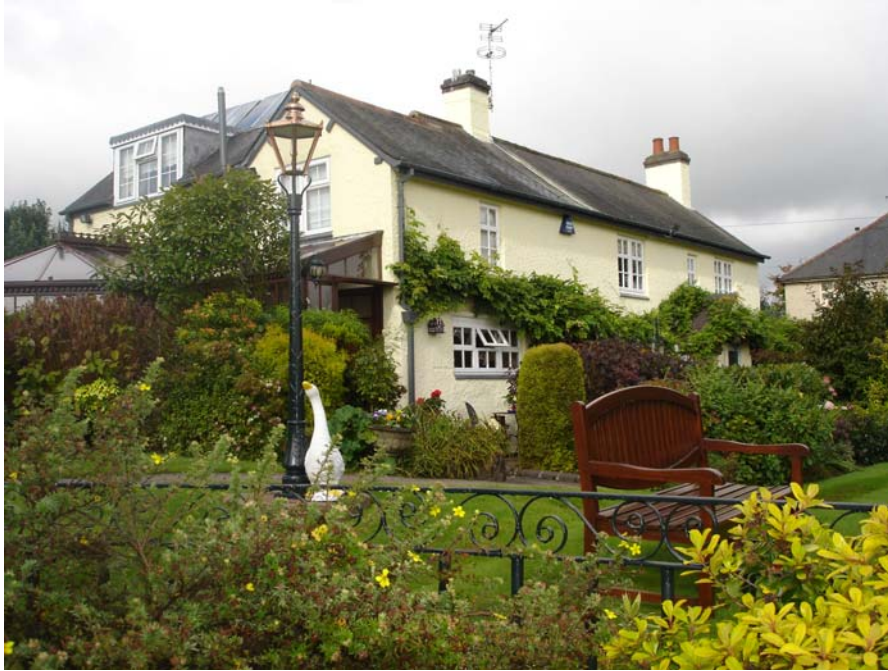
43 Markfield Road has been considerably enlarged to its rear. The side dormer window, solar panels and plastic windows are not traditional features; fortunately, they are not too prominent from the highway.

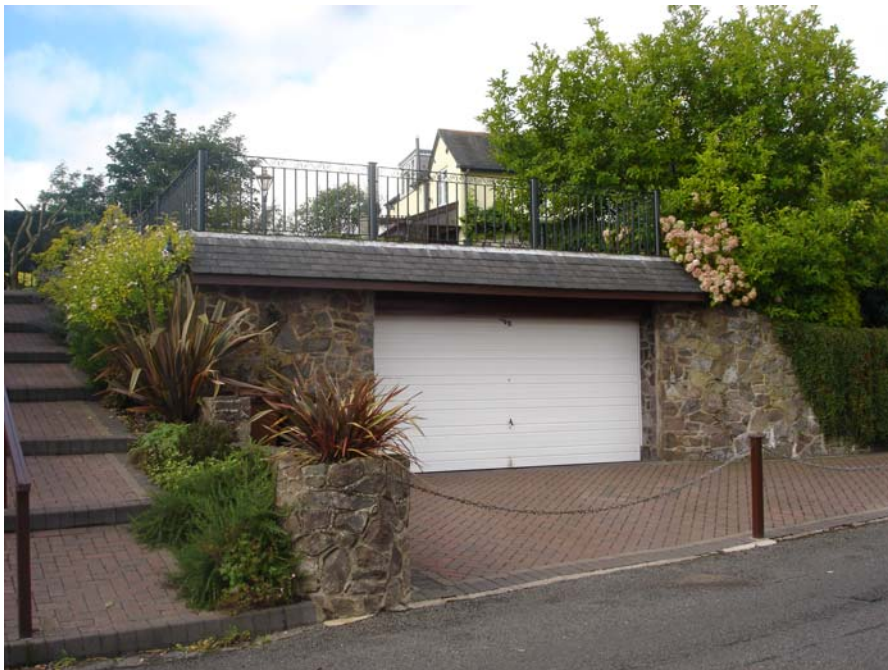
The modern garage and steps fronting 43 Markfield are particularly incongruent features in terms of its design, railings and surface treatment.

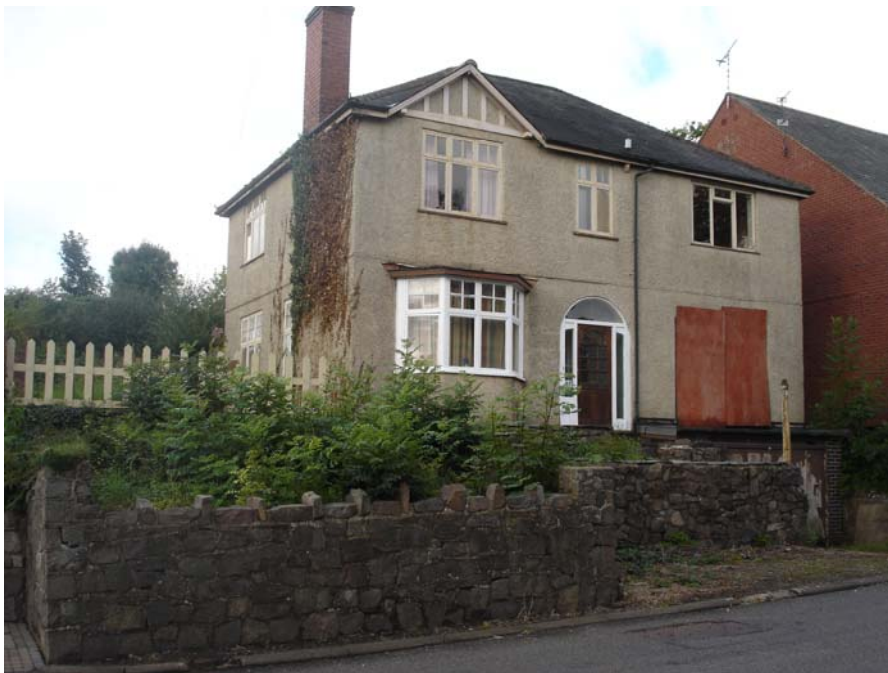
The side extension to 47 Markfield Road to provide an integral sunken garage detracts from the street scene.

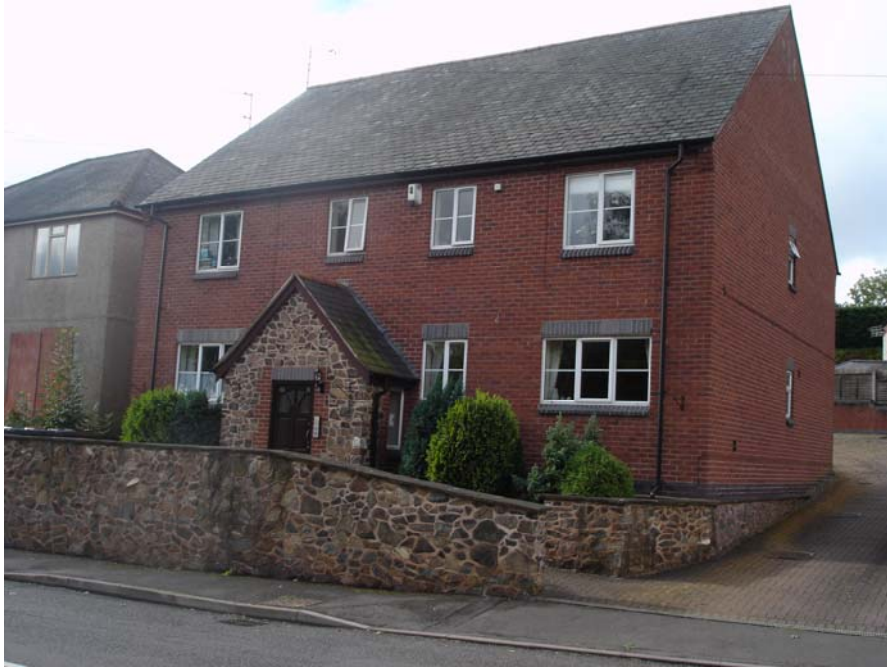
49 Markfield Road is a modern dwelling. Stone has been used as one of the building materials, unfortunately, the stone and pointing do not match the traditional style of granite walls in the conservation area.

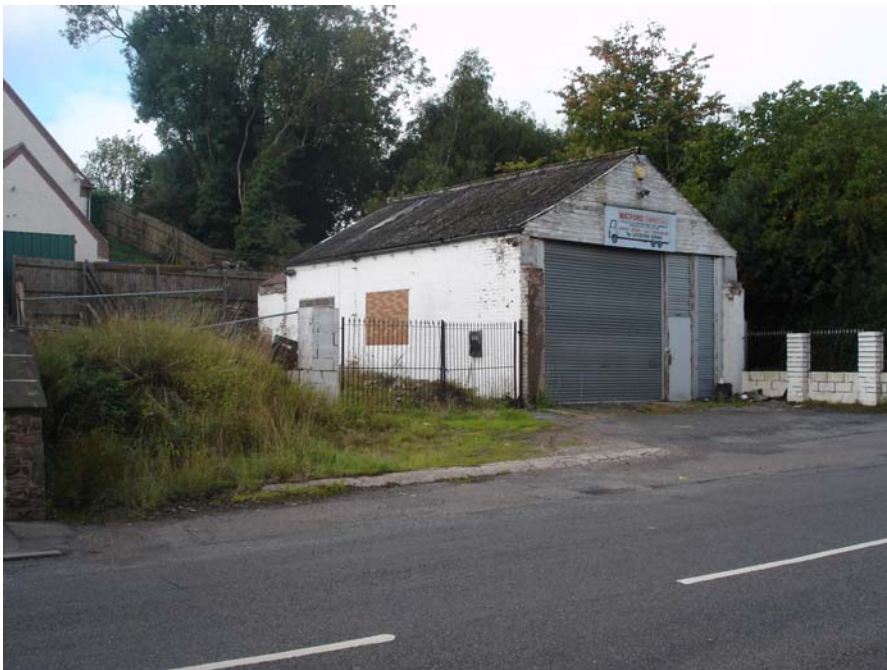
This former motor vehicle repair garage on Markfield Road is a particularly unattractive building in the conservation area. The site has potential for redevelopment.

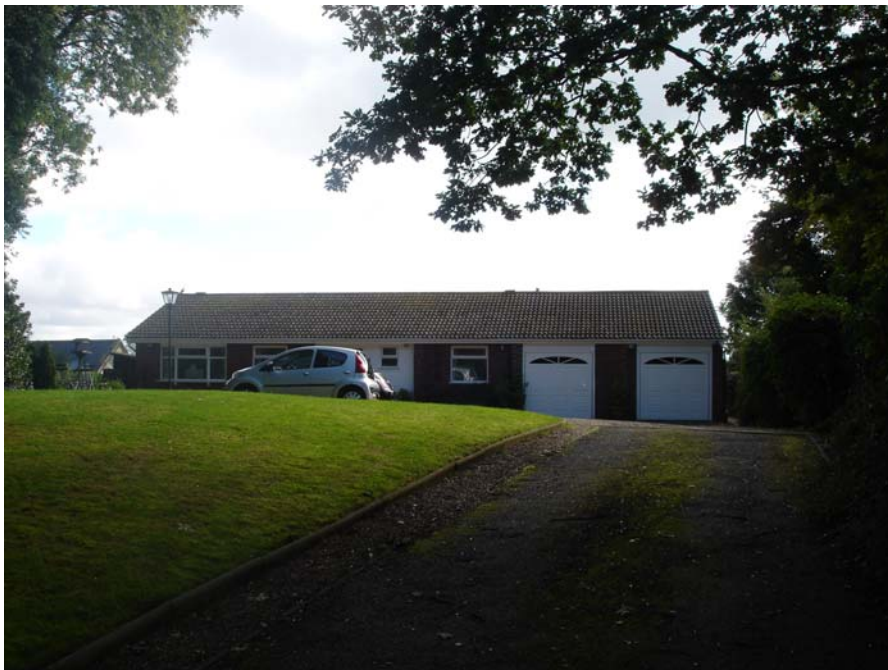
53a is a modern bungalow that unfortunately does not reflect the character of the conservation area do to its modern design and materials of construction.

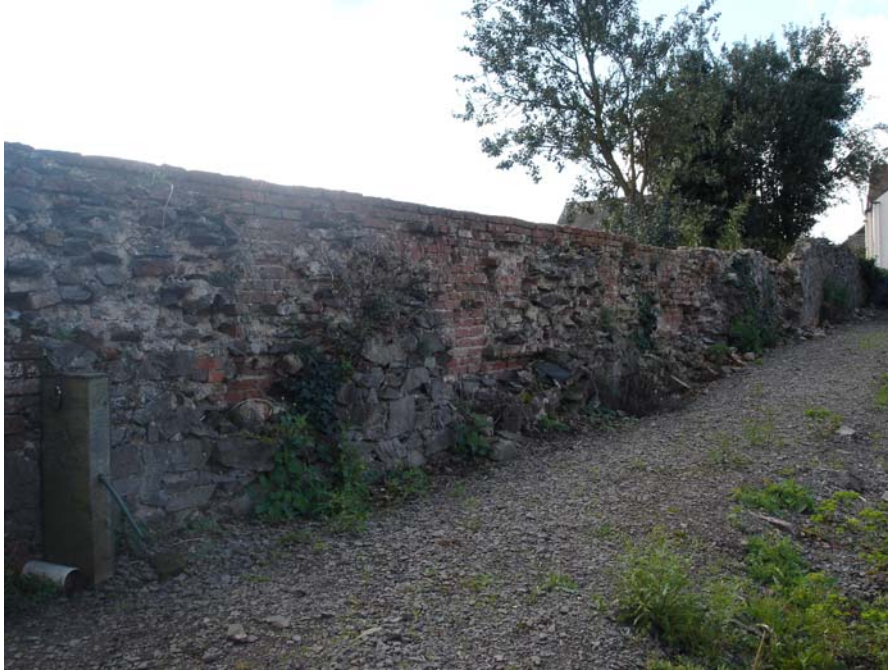
This wall sited in the allotment gardens on Markfield Road is believed to be part of the Old Hall's gardens. However, it should be retained and needs repairing.

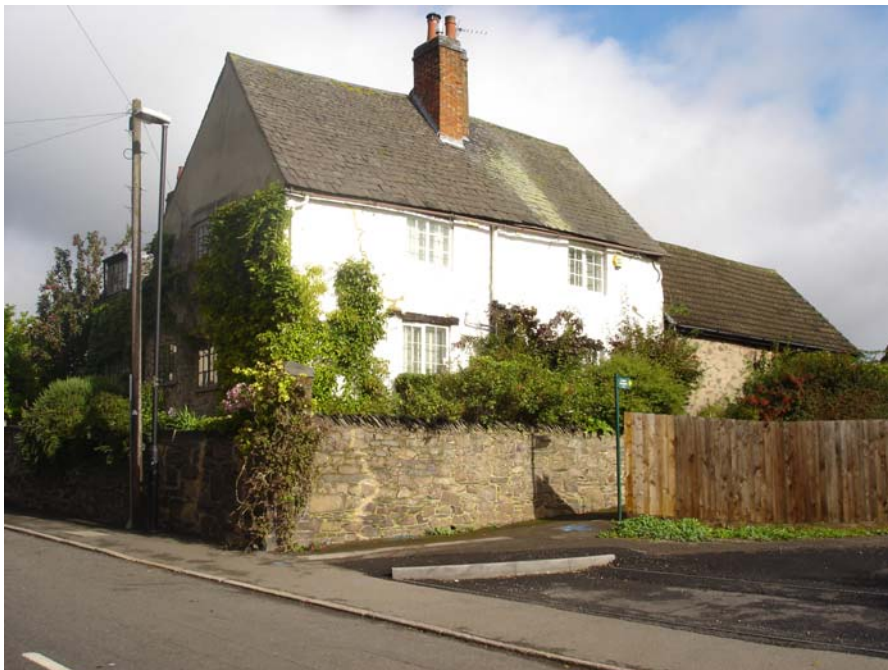
30 Markfield Road is a Grade II listed C16 timber framed property that has been overbuilt in Mountsorrel granite and colour washed. Unfortunately, the adjoining building has been re-roofed with concrete tiles. These should be replaced with natural slate in the long term.

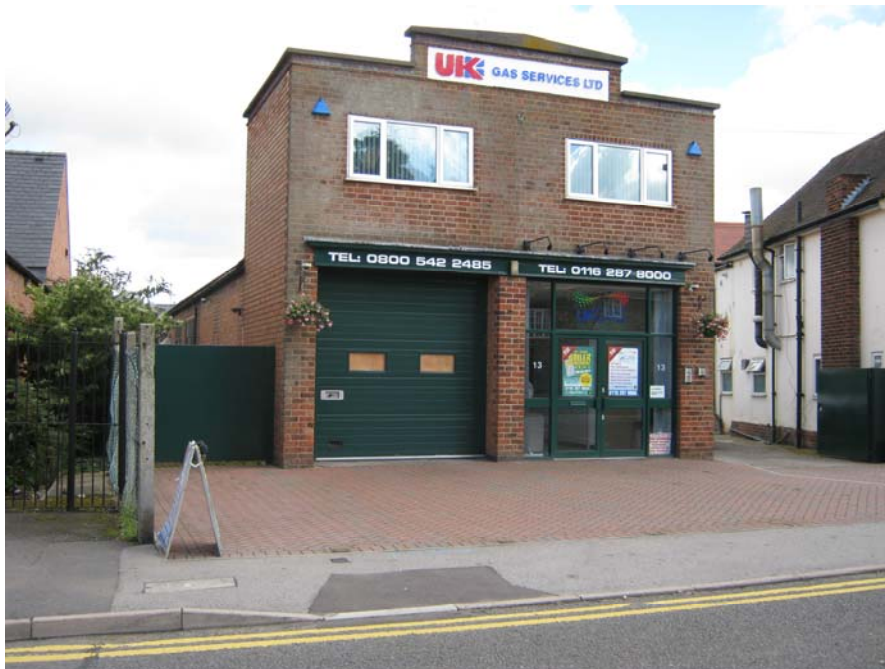
The commercial premises on Leicester Road is a particularly unattractive property in the conservation area due to its modern design, siting and poor surface treatment.

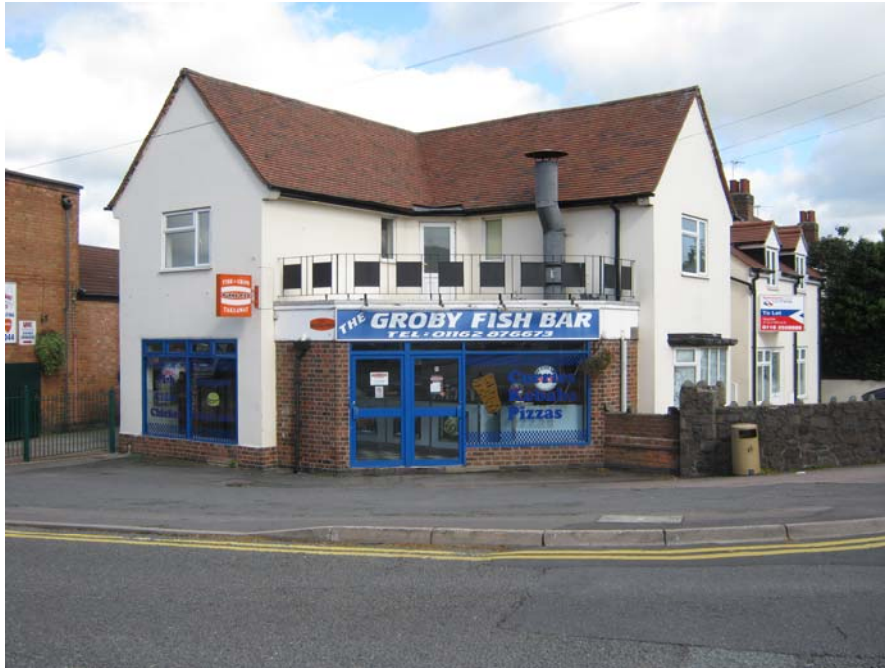
This inappropriate shop front added to 1 Newtown Linford Lane has a detrimental impact on the street scene by way of the over dominant signage, colour scheme, balcony and extractor flue.

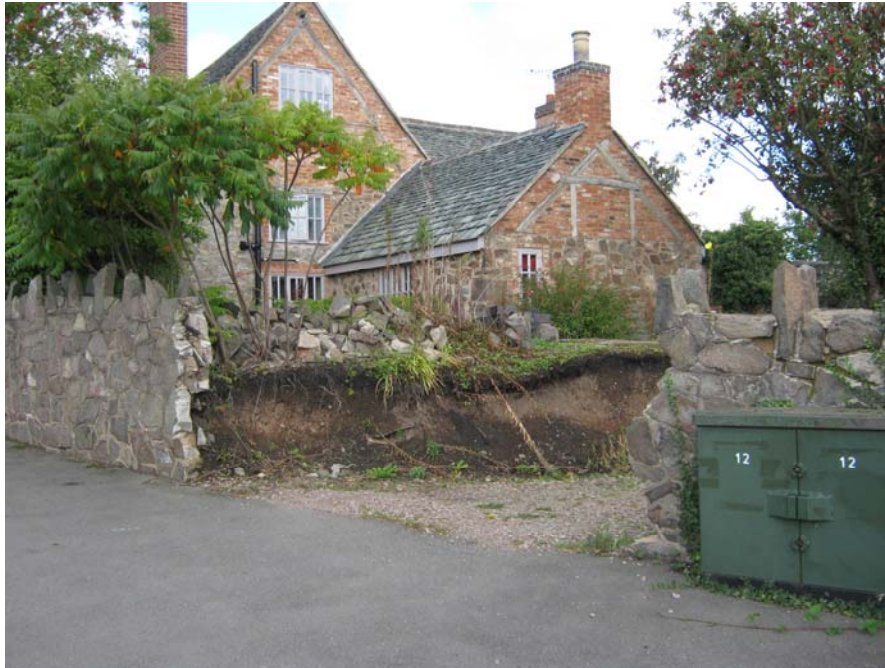
57 Leicester Road is an attractive timber framed cottage that has been modernised by having its roof raised and thatched roof replaced with slate. A new garage is to be constructed in the garden.

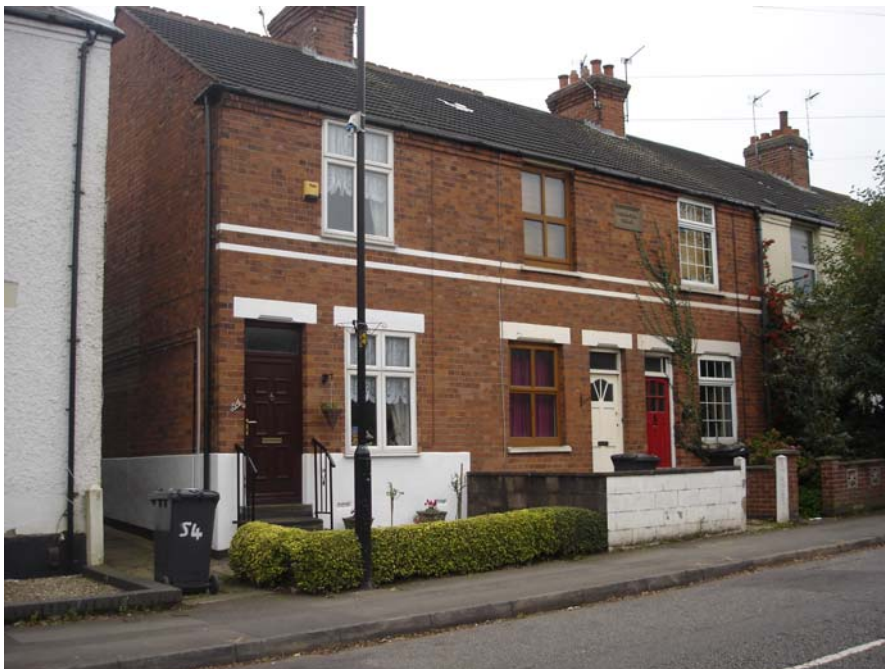
The unity of Victoria Stone Terrace has been lost due to modern improvements. The terrace, however, has retained its impressive chimney stacks.

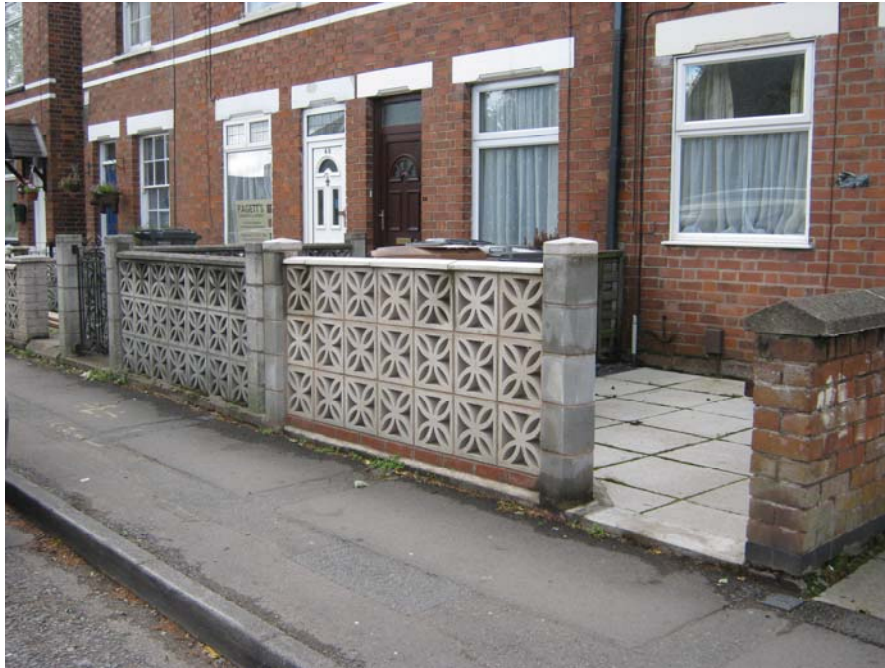
This particular wall treatment on Leicester Road is unacceptable clashing with the character of traditional stone walls in the conservation area.

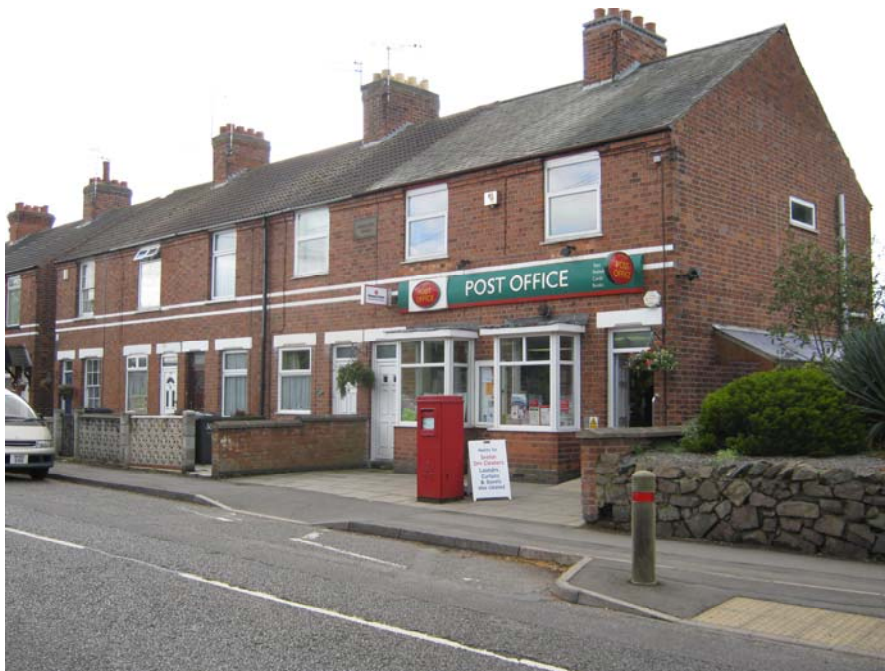
The bay window and over dominant shop fascia sign fronting the post office have a detrimental visual impact on the character of Victoria Terrace.

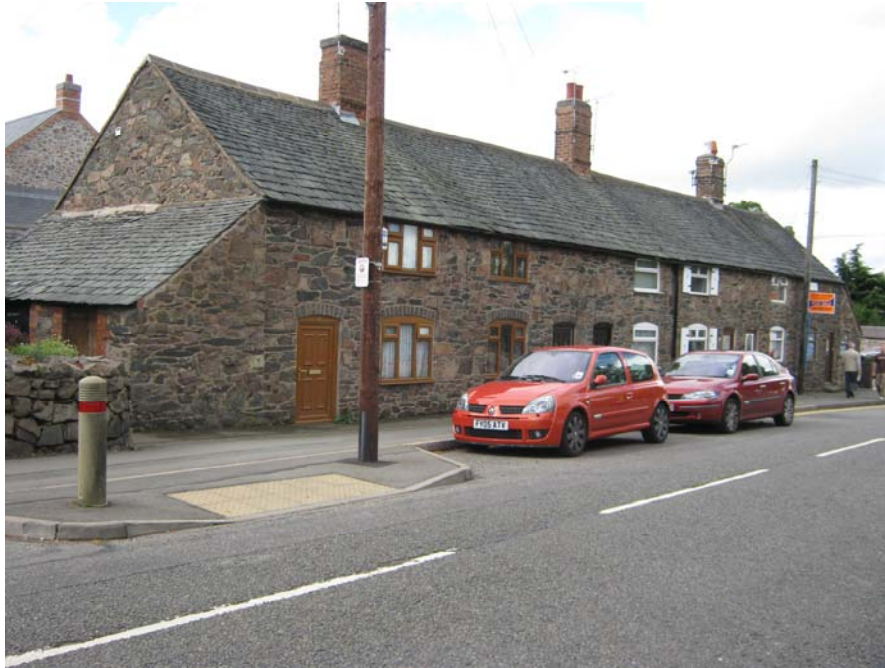
The unity of this terrace of stone properties on Leicester Road has been compromised by the inappropriate modernisation of its windows, doors and loss of some chimney pots.

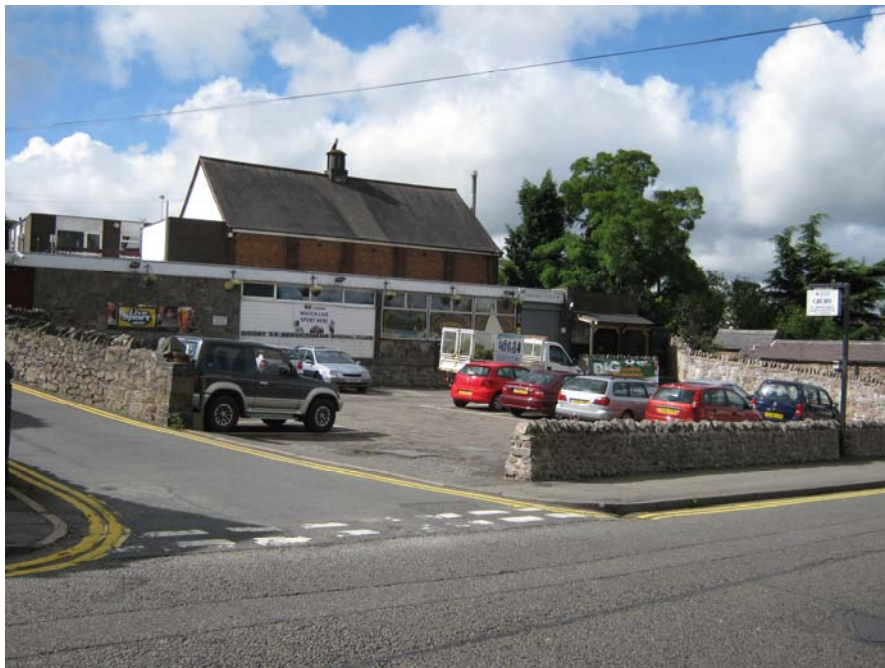
The flat roof front extension to the Ex-Sevicemens' Club sited opposite Newtown Linford Lane has an unfortunate detrimental effect on this part of the conservation area. The traditional stone walls, however, help delineate the Club's car park boundary.

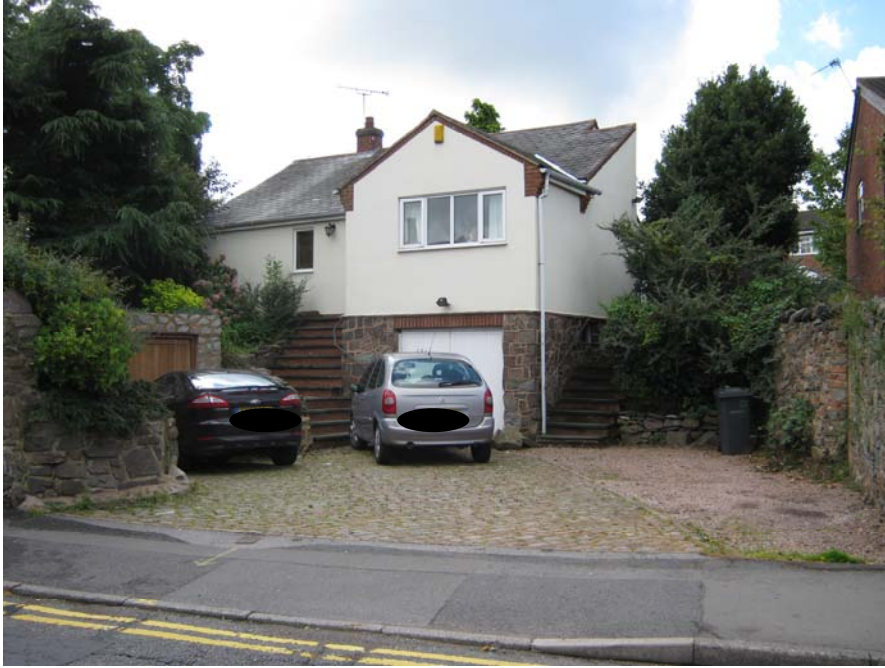
The half rendered split level bungalow, 12a Leicester Road, with its integral garage does not reflect the traditional character of the conservation area.

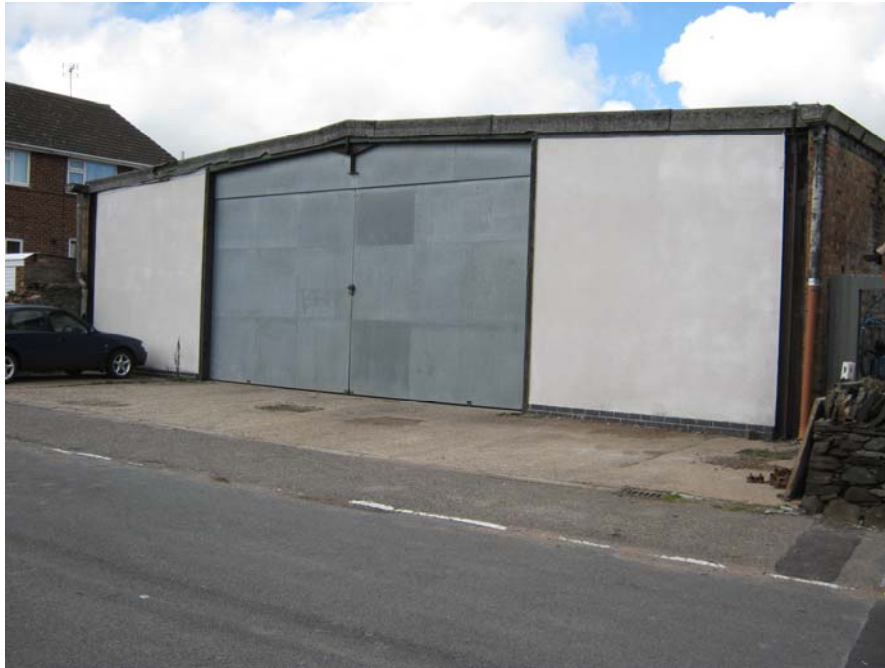
The large haulage garage located on the Rookery is out of character with the narrow side road in terms of its design, materials and use.

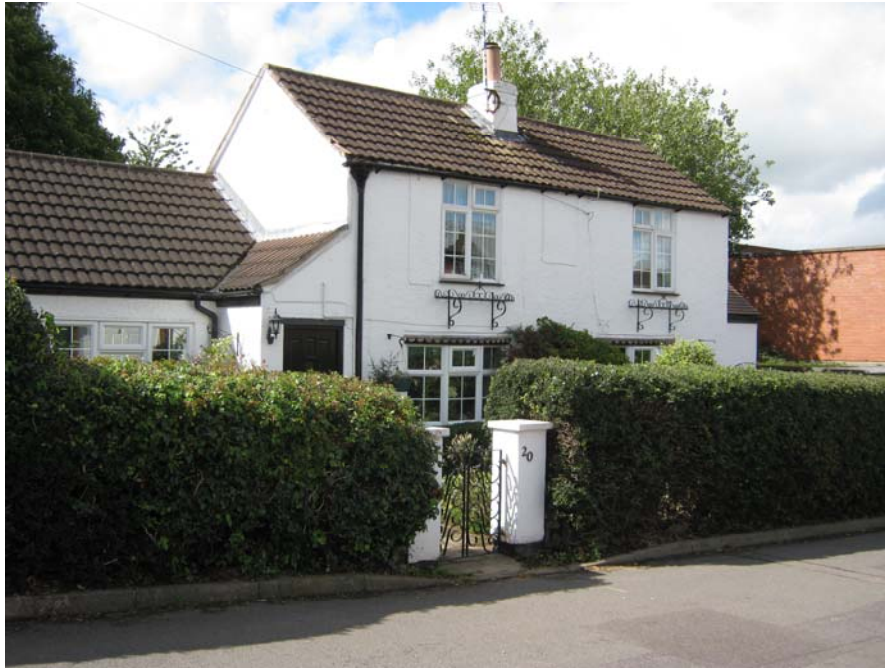
This cottage on Rookery Lane has lost its traditional character with the use of concrete roof tiles and installation of bow windows.

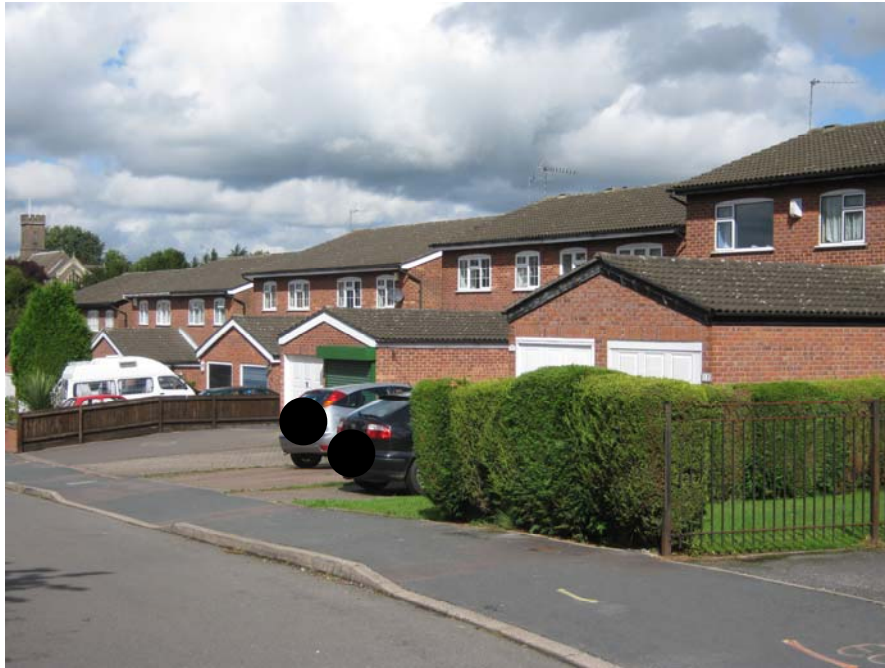
This modern housing development on Rookery Lane does not reflect the traditional character of the conservation area in terms of design, materials and open frontage.

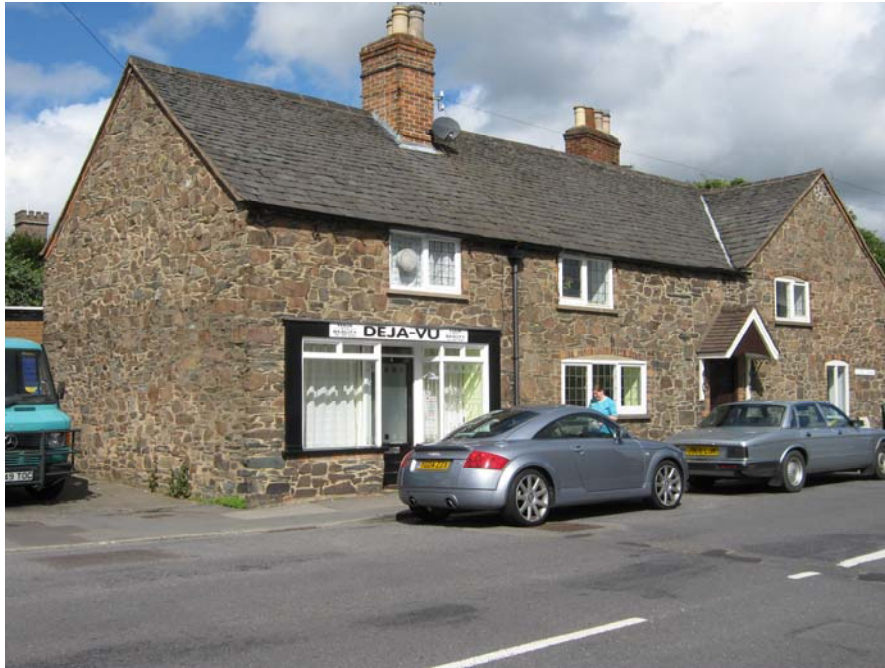
The stone premises on Ratby Road are charming due to their simplicity. The slate roof and chimney stack adds character to the conservation although the prominent position of the satellite dish is unfortunate.

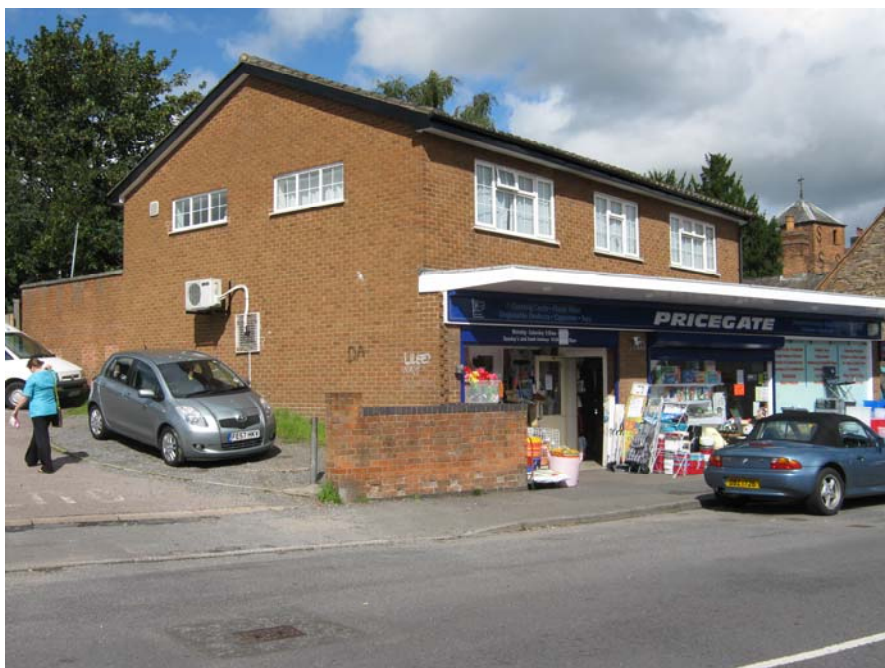
This large modern property and the external treatment of the shop front are far too brash and prominent in the centre of the conservation area. Consideration needs to be given to reduce its visual impact in the street scene.

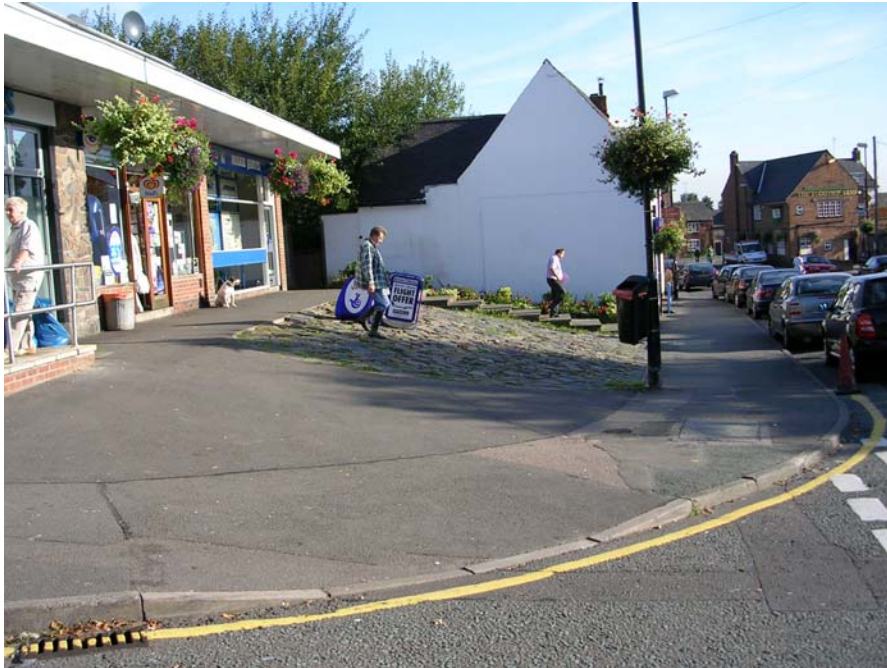
The crazy paving fronting the 24 – 28 Ratby Road is unsightly and needs replacing with some form of landscaping that will help to soften the area and define the boundary.

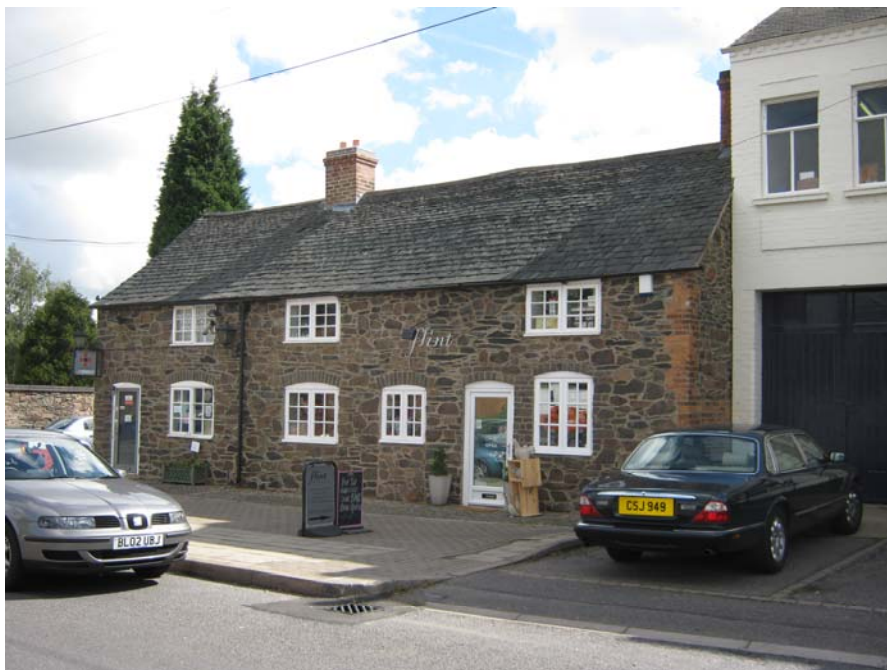
The cottages, 11 & 15 Ratby Road, are simplistic in their design and choice of natural materials although the street doors are out of character.

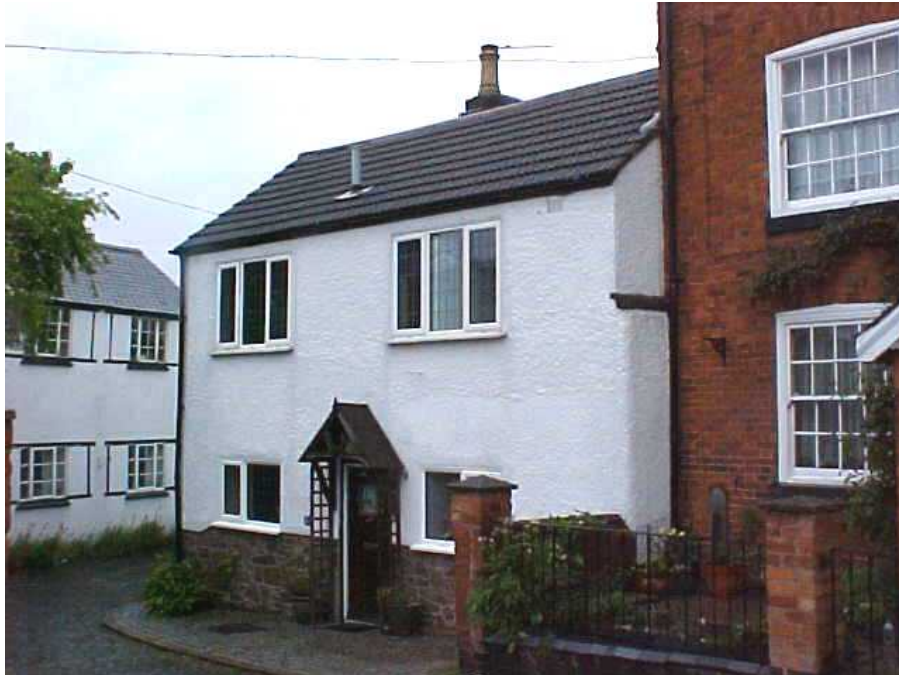
31 Chapel Hill was once a Grade II listed property built in red brick with slate roof with a south side façade jettied out with rough cast 1st floor. However, the dwelling was de-listed due to its modernisation with concrete roof tiles and plastic windows.

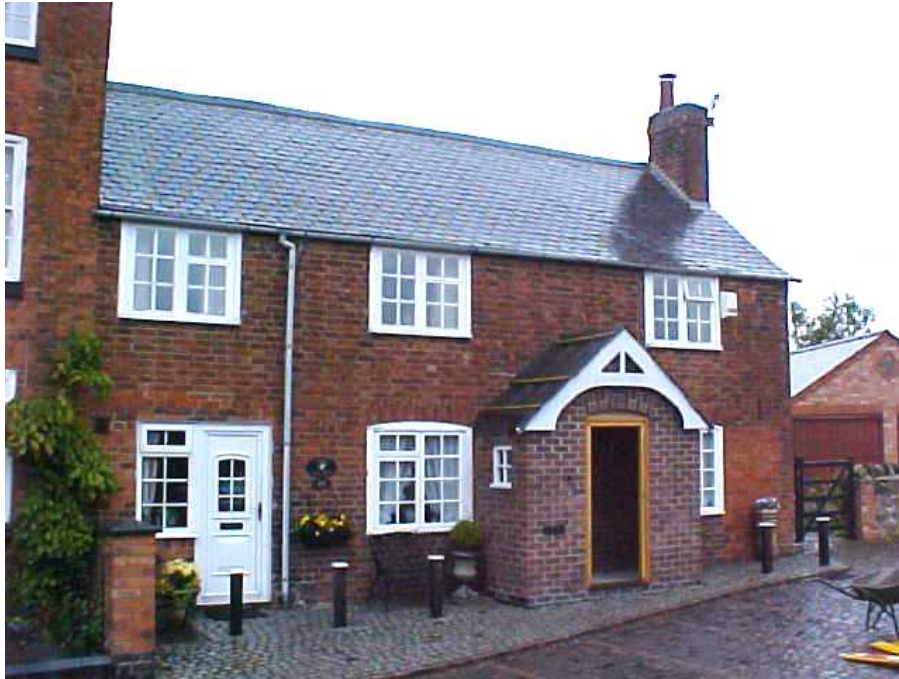
35 Chapel Hill has suffered from the installation of a modern door and construction of an over dominant front porch.

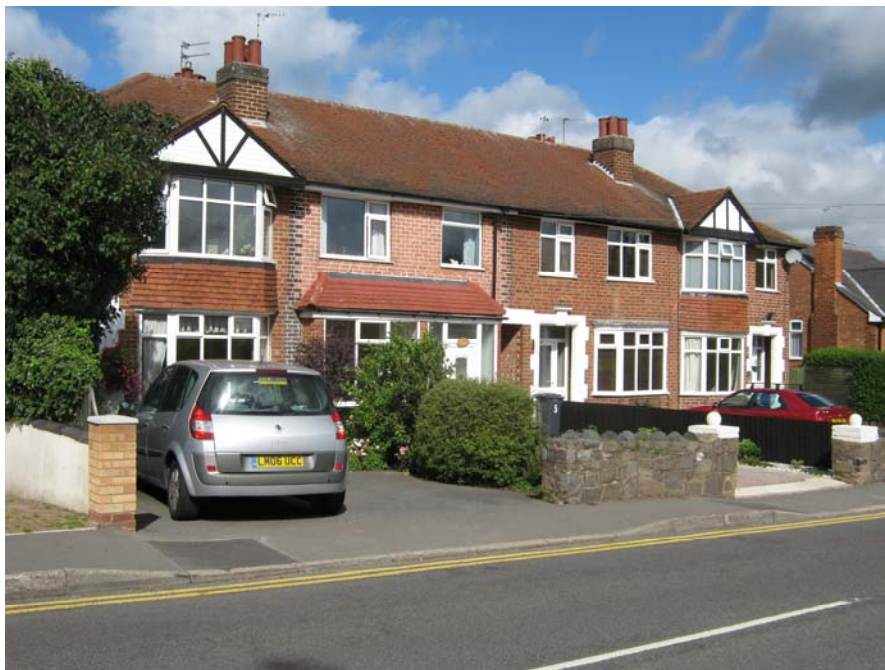
The unity of the terrace 3 – 9 Newtown Linford Lane has been lost due to modern improvements.
