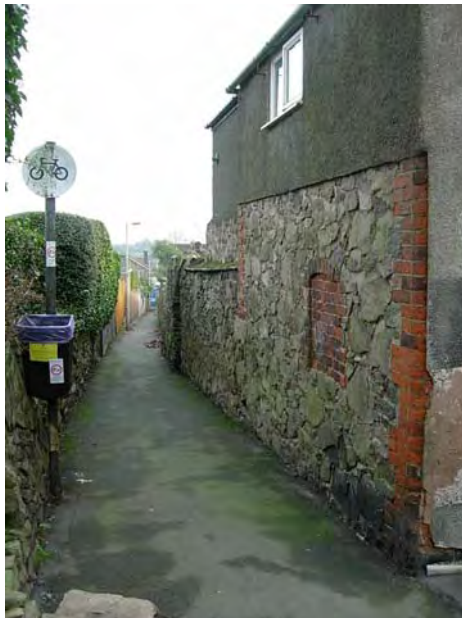
The jitty that runs from the northern end of The Green to Main Street is one of several jitties often flanked by important granite walls. These pedestrian routes traditionally linked Main Street to the ambient farmland.

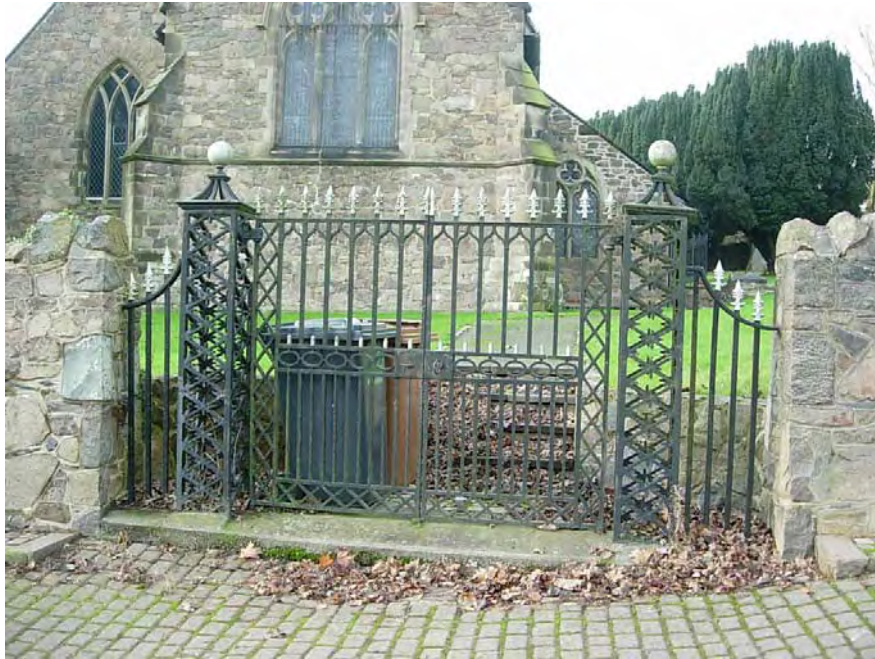
Cast iron gates circa 1820 with their pierced openwork side piers. The Grade 2 listed gates are an excellent feature sited on the east side of St Michael's Church.

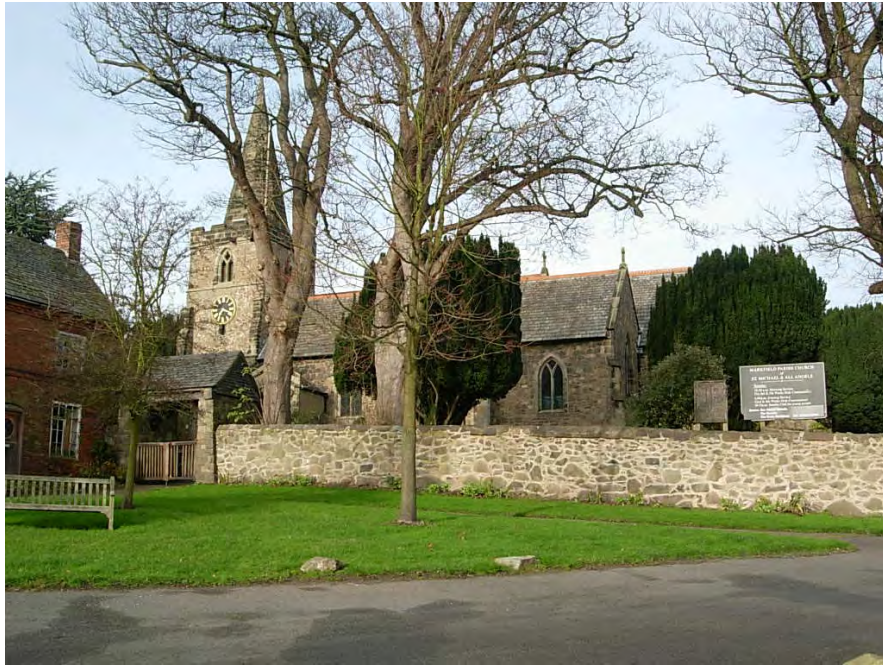
The Grade II\* listed parish church of St Michael built in granite with slate roofs and a short spire is a prominent landmark in Markfield. The Church is flanked by excellent granite walls and the graveyard contains some fine mature trees and interesting gravestones.

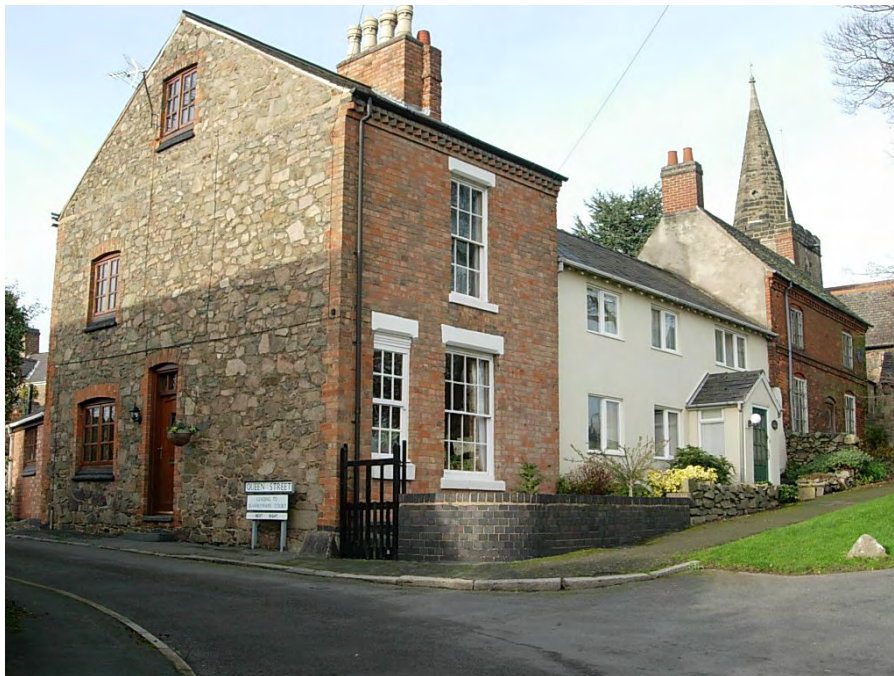
The dwellings adjacent to the church lichgate provide a fine setting for the church with their different roof heights and materials.

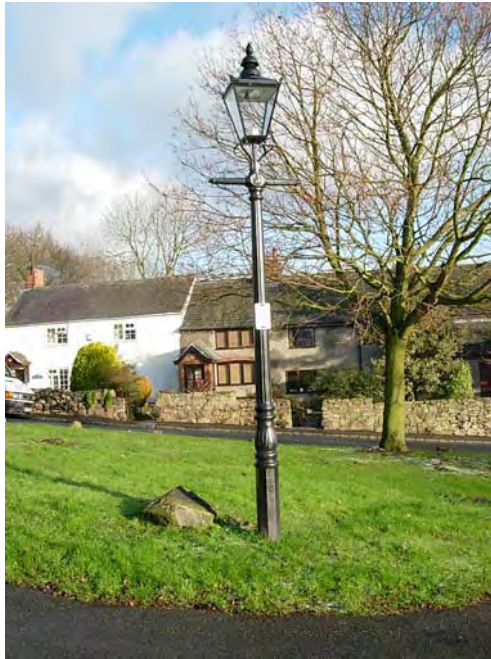
Several traditional cast iron heritage street lights have recently been installed sited around the village greens which add to the charm of the conservation area.

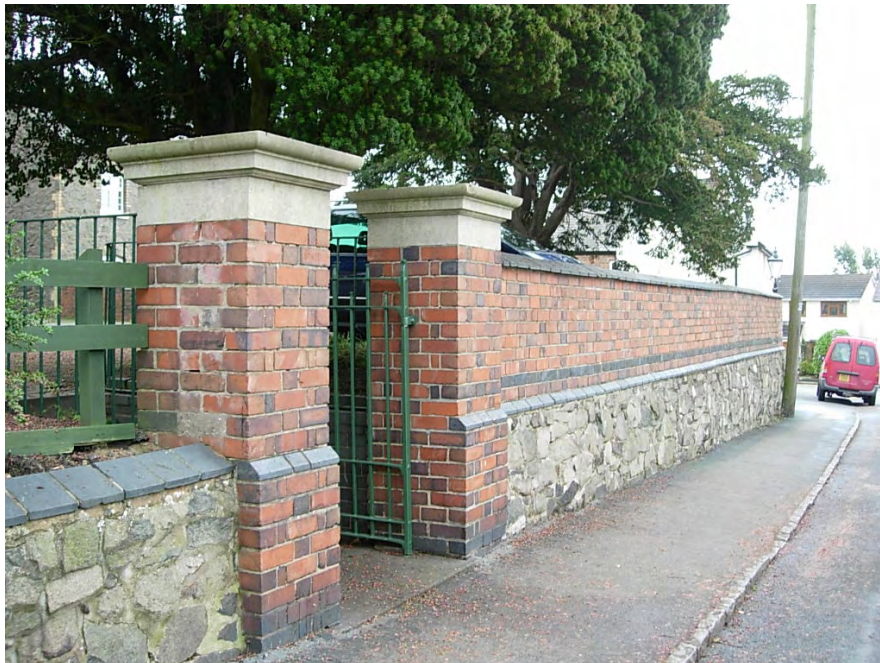
This solid brick wall that stand on a granite base is a dominant feature fronting the former village primary school and should be retained.

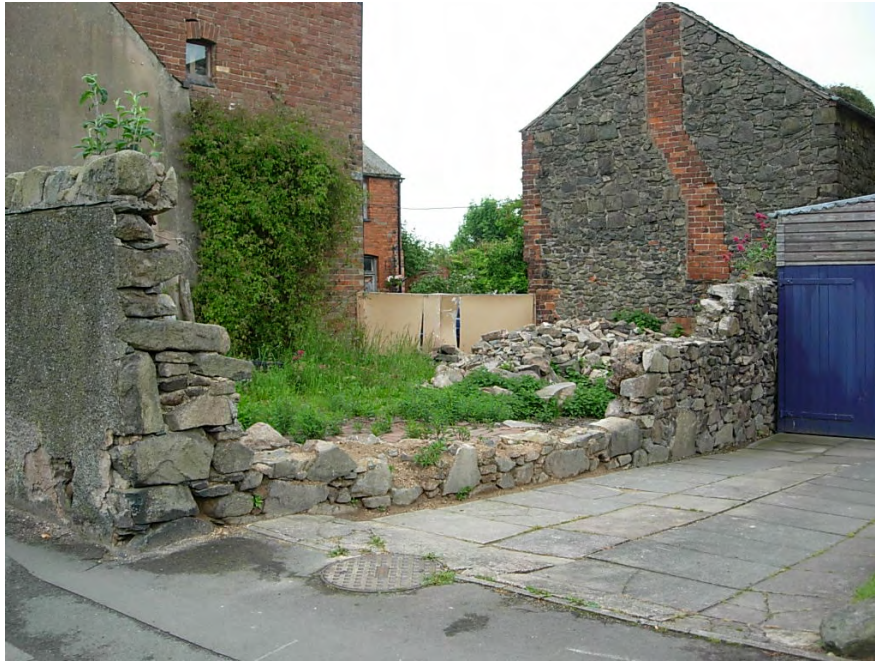
Granite walls are a dominant feature in the conservation area that need to be retained. The Borough Council has in the past provided small grants in order to help retain these important features.

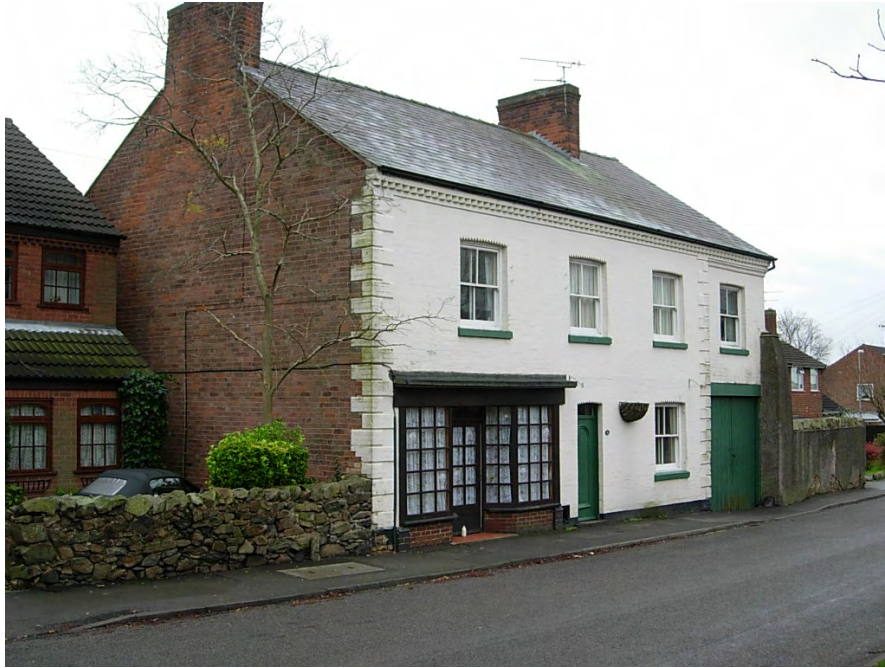
36 Main Street was once the village bakery. The property has now been converted into a dwelling although the shop front and bake house still remains.

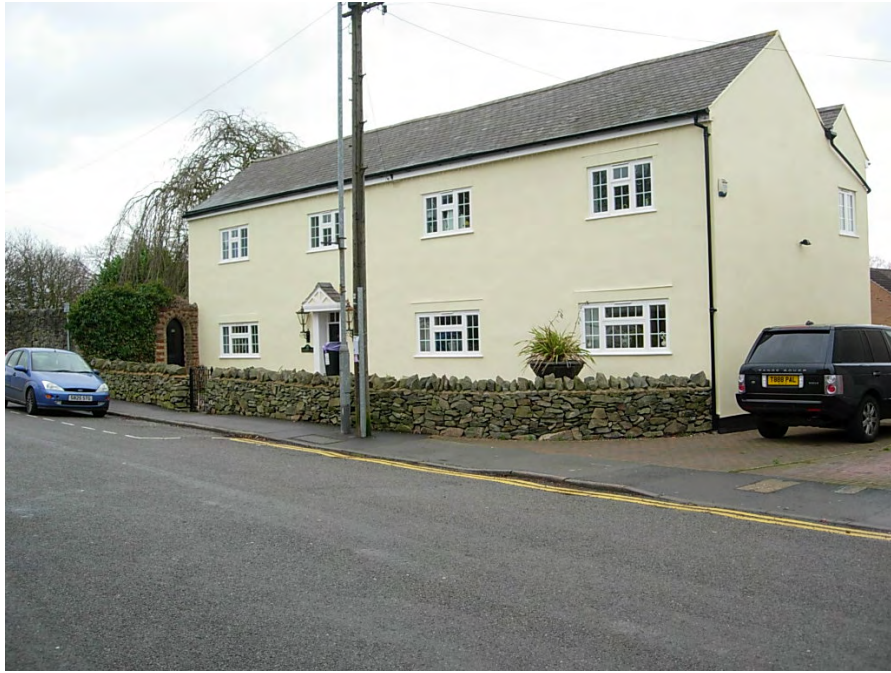
54 Main Street, formerly a mill, is an attractive building that has an excellent granite wall fronting the premises.

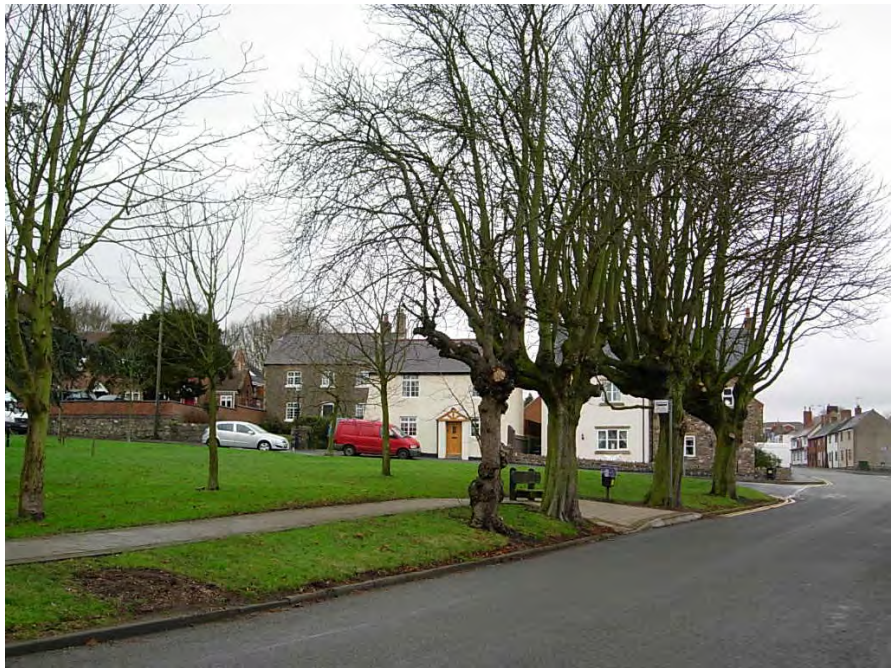
Saw Pit Green and the roadside trees soften the built environment at the southern end of Main Street.
