GROBY CONSERVATION AREA APPRAISAL & MANAGEMENT PLAN

**PHOTOGRAPHIC SURVEY OF
GROBY CONSERVATION AREA**

November 2010

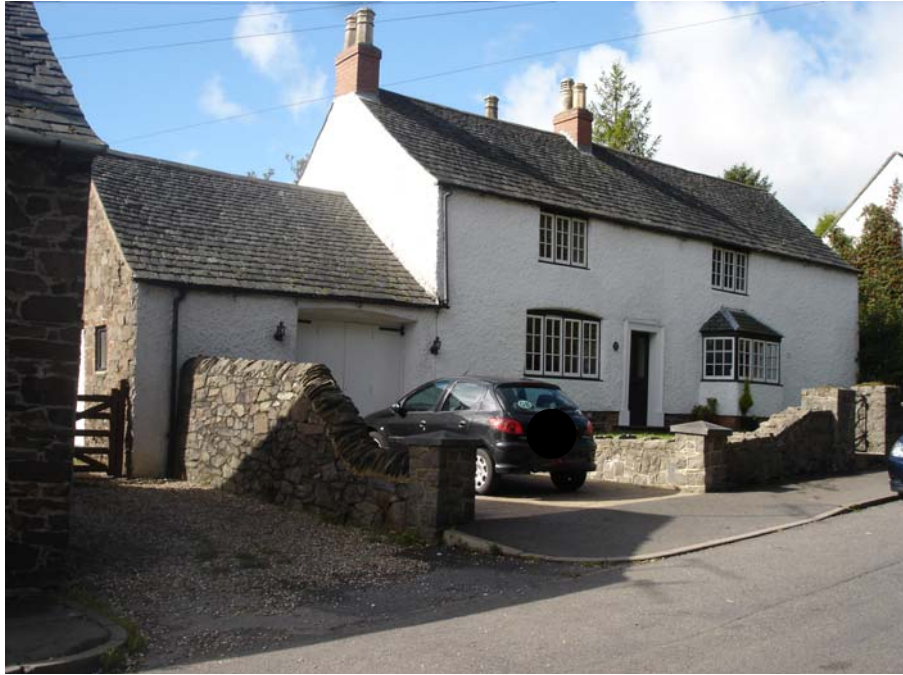
11 Markfield Road is a large rendered dwelling, painted white, with a stone plinth, slate roof and stone boundary walls. The property still has chimney stacks and pots and a front bay window has been added.

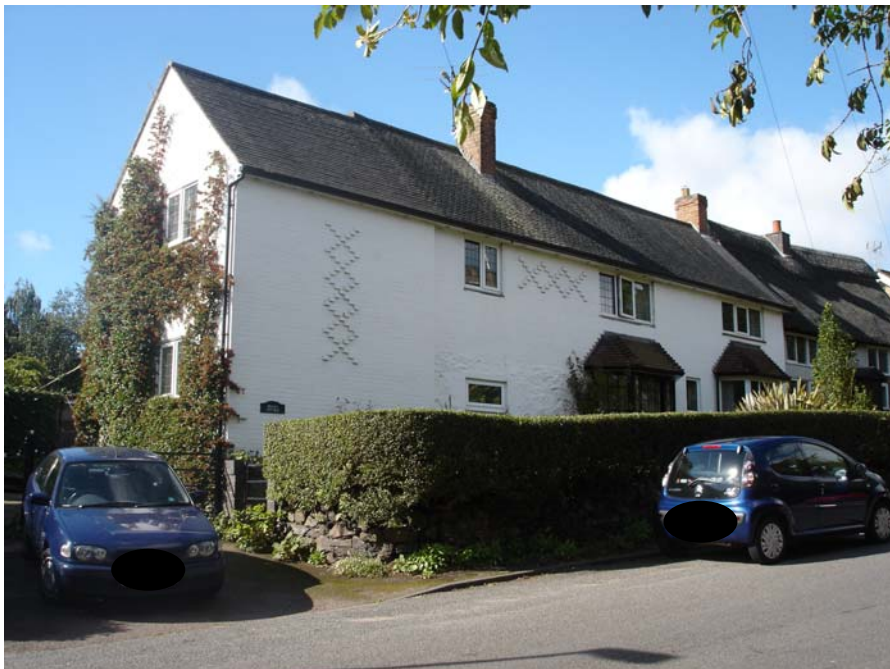
13 Markfield Road is a large imposing dwelling with two front bay windows and a fine privet hedge. The property is rendered, painted white with a slate roof and interesting diaper brickwork.

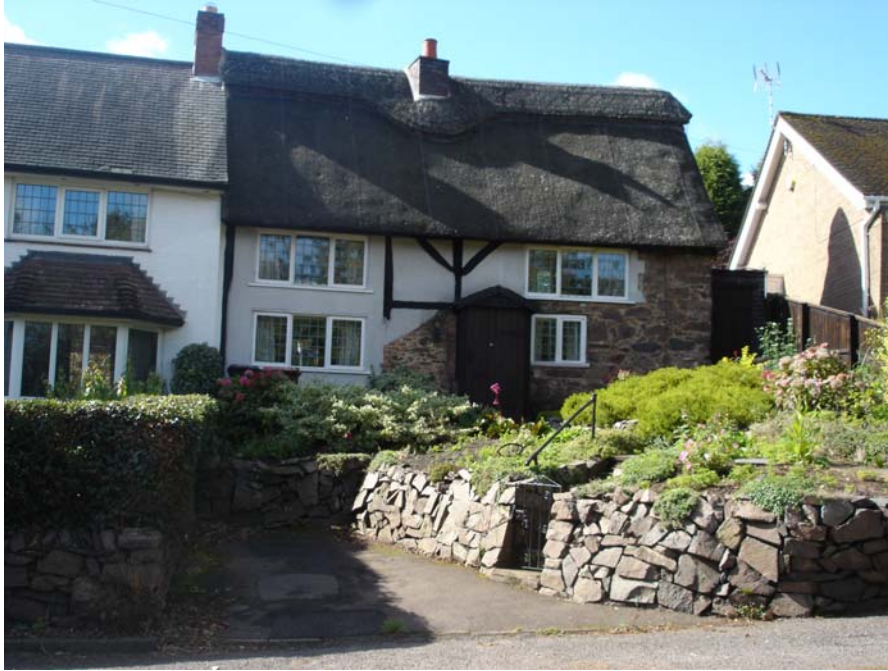
This charming thatched cottage, 15 Markfield Road, has one half of its front elevation built in stone and the other rendered.

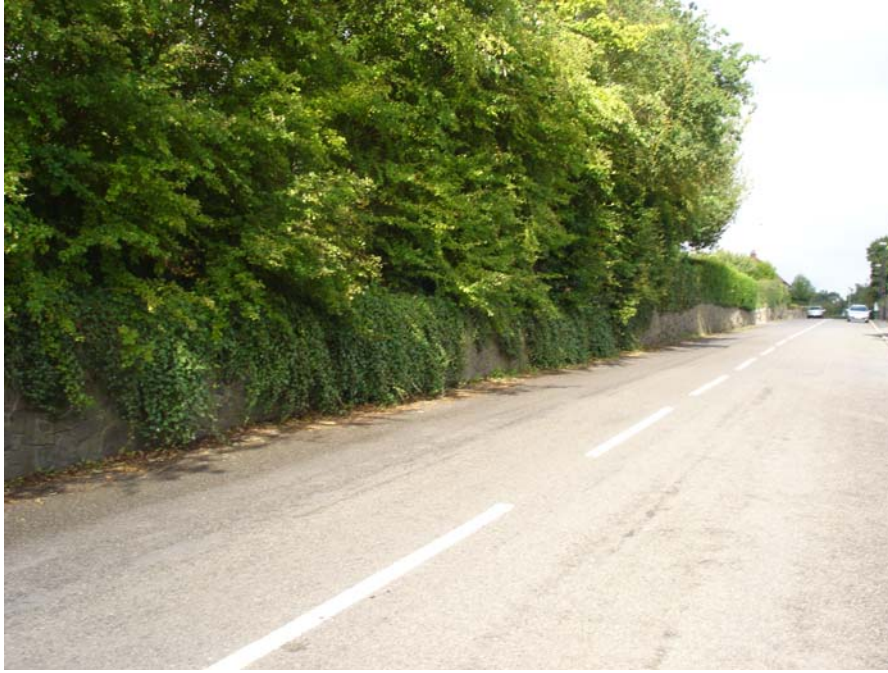
View looking westwards along Markfield Road showing a traditional stone wall running up the carriageway and planting on the left where a mineral railway line once crossed under the road. The planting helps to screen views into the Fir Tree Lane Industrial Estate from the footpath opposite.

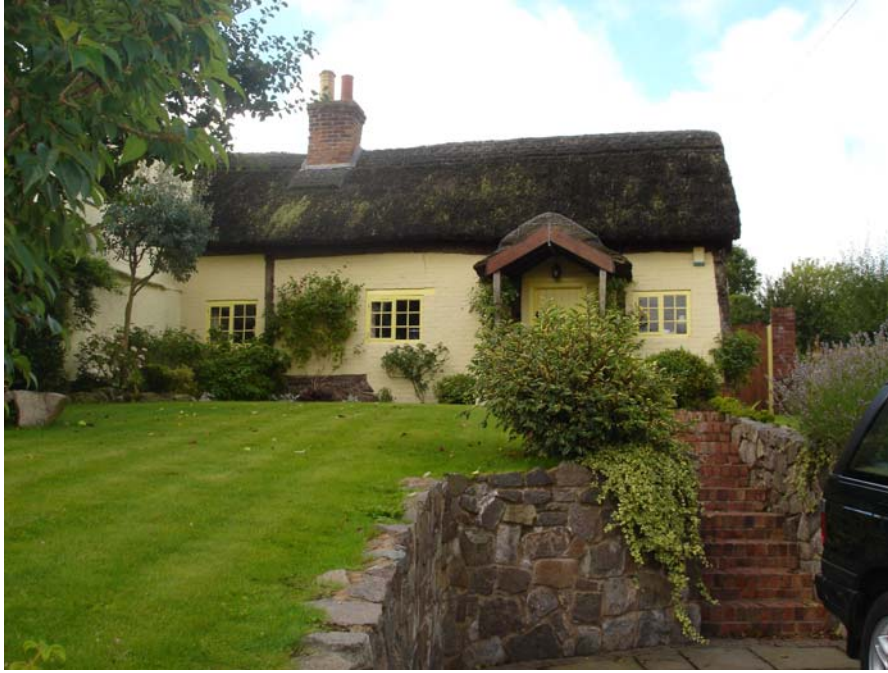
45 Markfield Road is an attractive little C16 cottage that has kept its traditional character. The thatched timber framed property underbuilt in brick is a Grade II listed building painted in a pastel colour. The cottage has kept its original window openings and chimney stack and its C19 rustic porch is in proportion to the property.

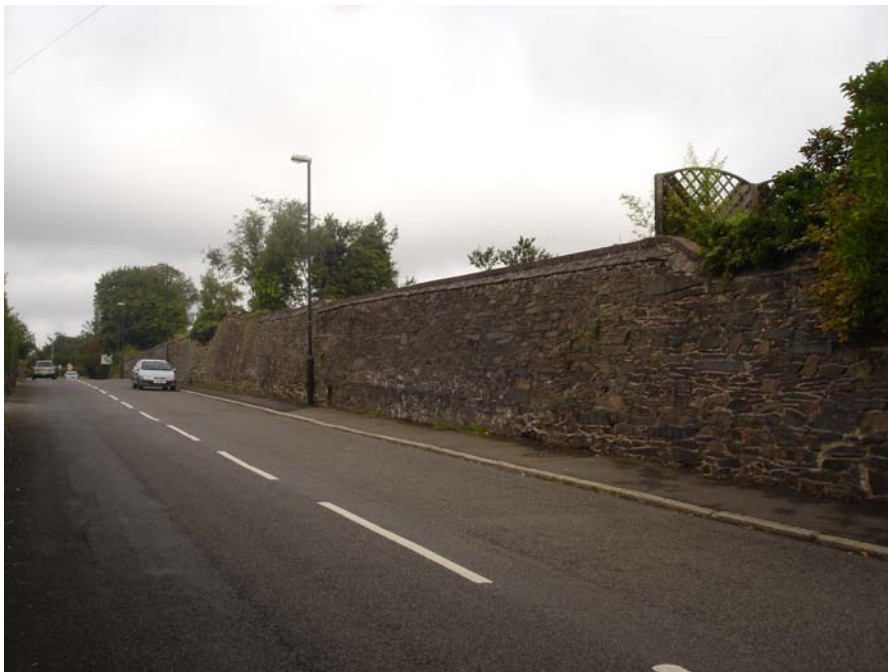
The excellent stone retaining wall runs up the north side of Markfield Road flanking one of the village's allotment gardens. It is a key feature in the conservation area.

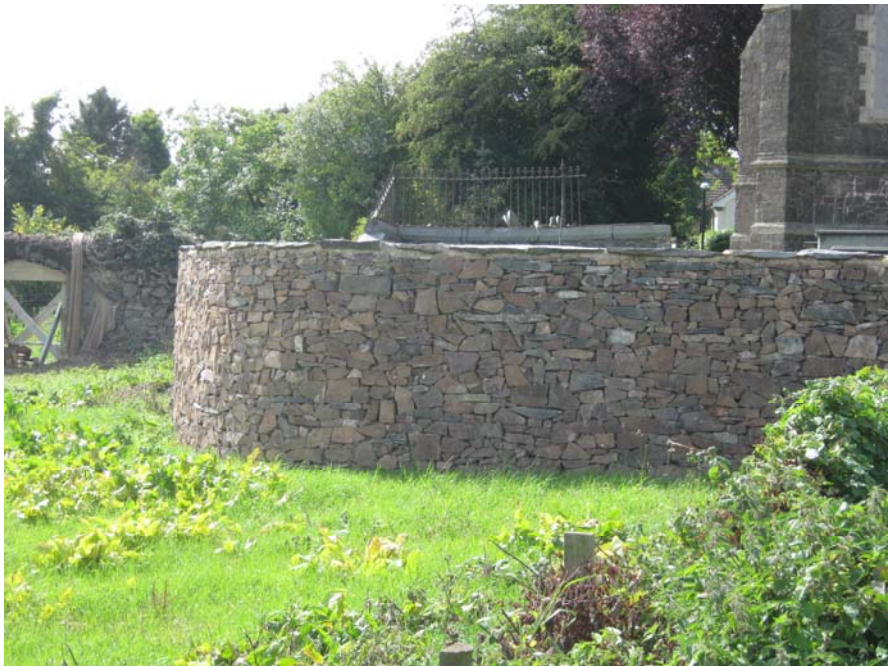
The churchyard wall has recently been re-built and is a good example of new stone construction.

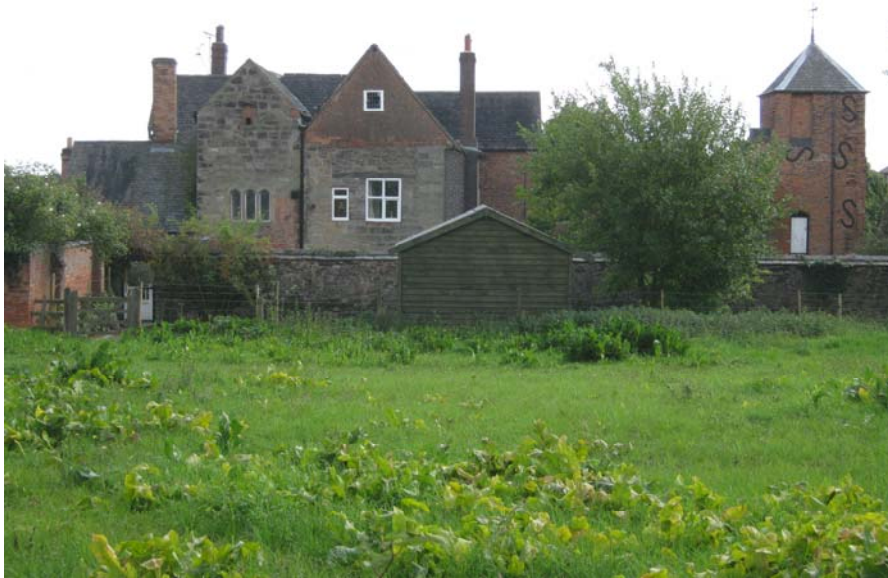
North-west view of Groby Old Hall and tower showing the right hand gable has been raised with brickwork.

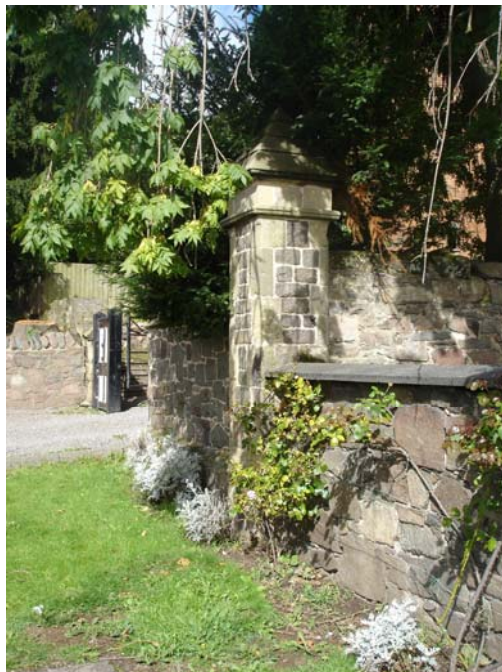
Stone pier fronting the Old Hall. The other pier on the western side of the access has been considerably reduced in height.

The slate coping on the adjacent wall is an interesting heritage feature.

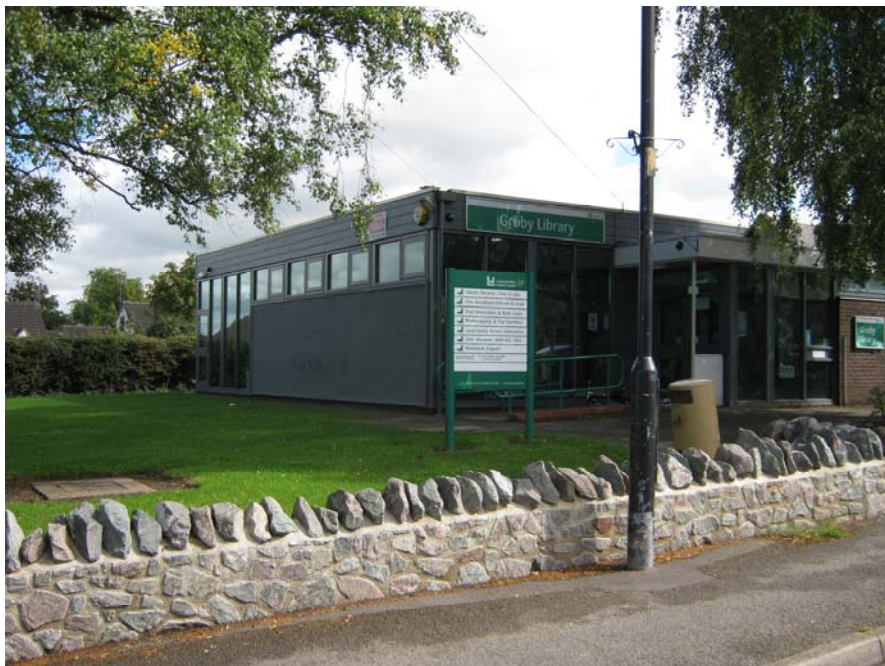
Groby Library is a modern property sited in a prominent position at the junction of Leicester Road and Newtown Linford Lane. The design of the building does not reflect the traditional character of the conservation area although the recently built stone wall helps to clearly define the library's boundary.

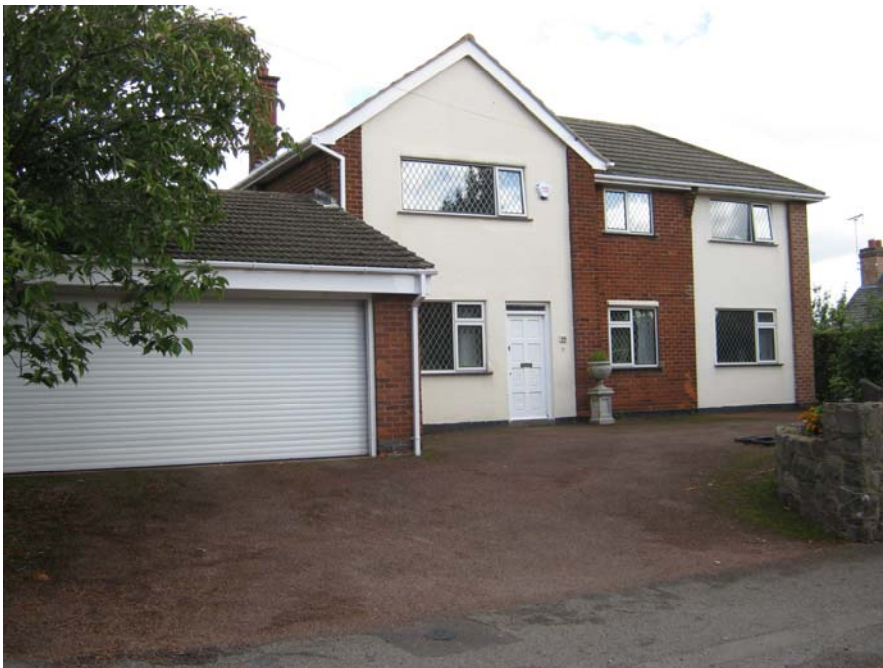
55 Leicester Road is a large detached modern dwelling that would have been better sited outside the conservation area due to its design and choice of materials.

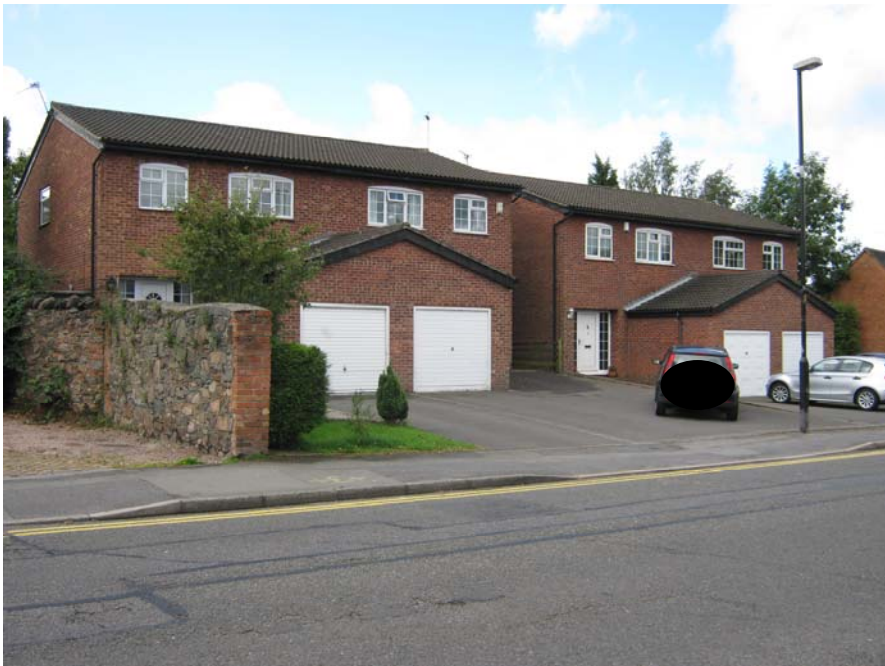
The four modern semi detached dwellings 4 –10 Leicester Road are out of character with the conservation area due to their design, use of modern materials and open frontage. The street scene would benefit if short garden stone walls were to be constructed to help reduce the length of open frontage.

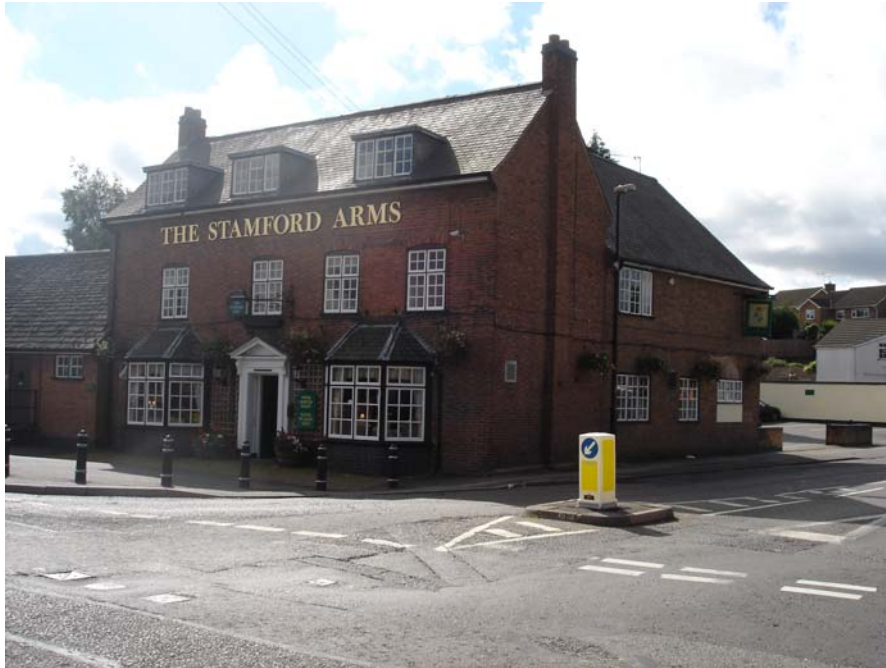
The Grade II listed late C18 Earl Stamford Arms Pub is built in red brick. It has a slate roof and 2 brick gable stacks. The roof was raised in C20 and 3 flat roof casement dormers were added.

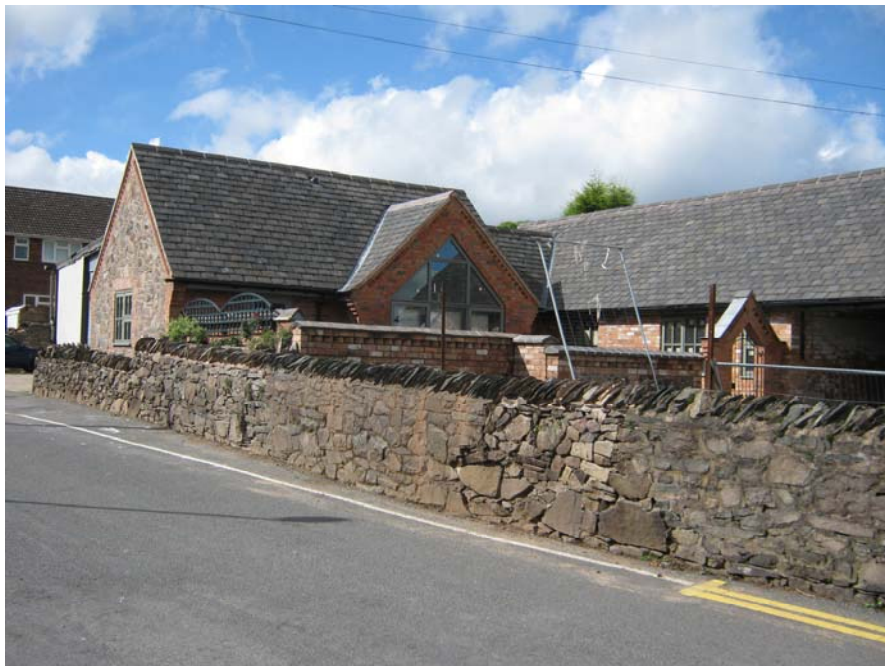
The former outbuildings on the Rookery are currently being converted into a dwelling. The existing granite wall has been retained as a condition of the planning permission.

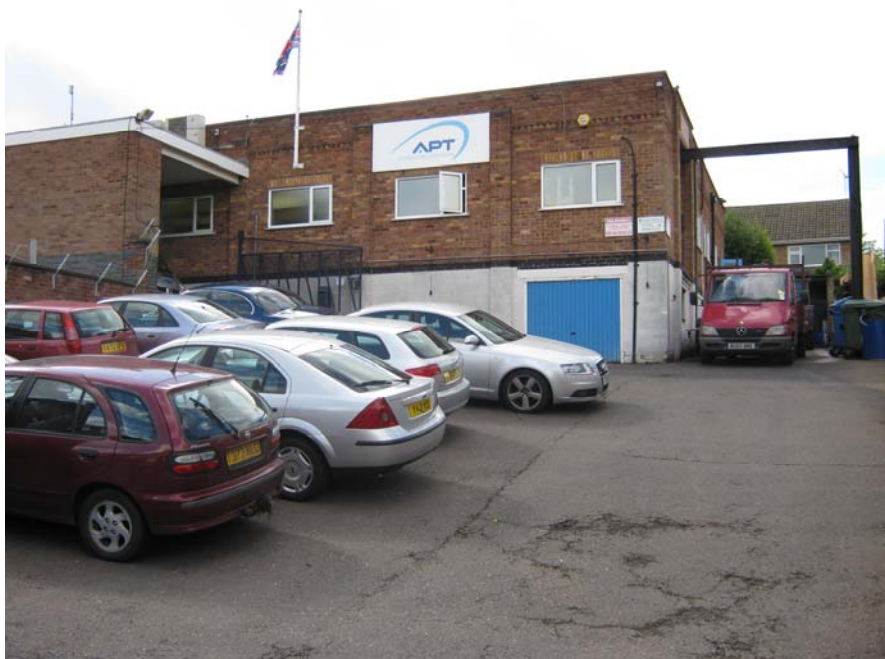
The APT factory, which is sited at the top of a steep gradient, is a particularly unattractive building that has a detrimental visual impact on Rookery Lane due to its poor design and modern materials.

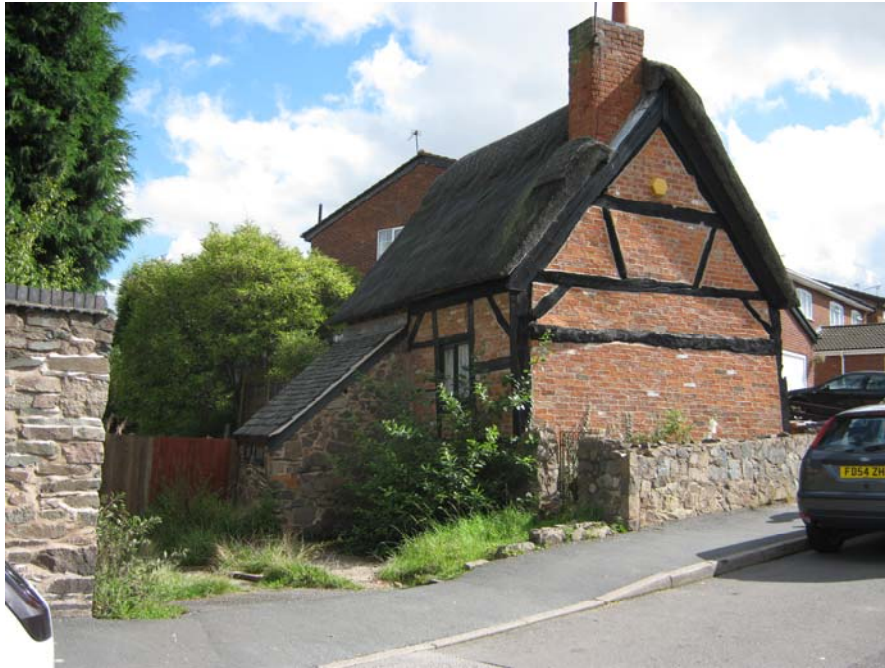
The Grade II listed Blacksmith's Cottage on Rookery Lane. The late C17 timber framed property with brick noggin and thatched roof has a single gable stack. This attractive little thatched cottage, that was once the site of the village blacksmith, was restored around 1980.

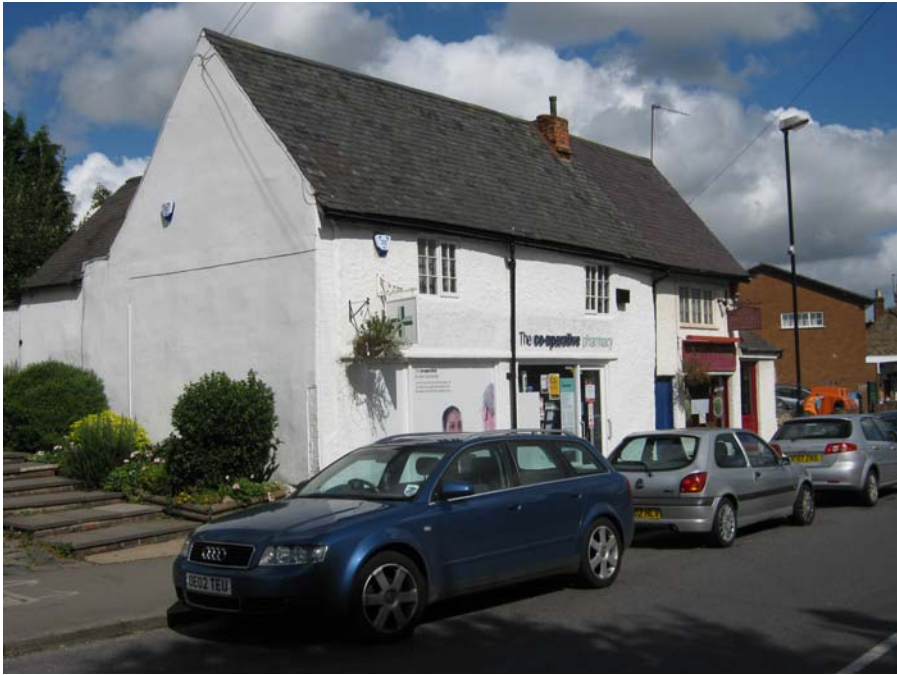
18 & 18a Ratby Road is a vernacular building that has been rendered and painted.

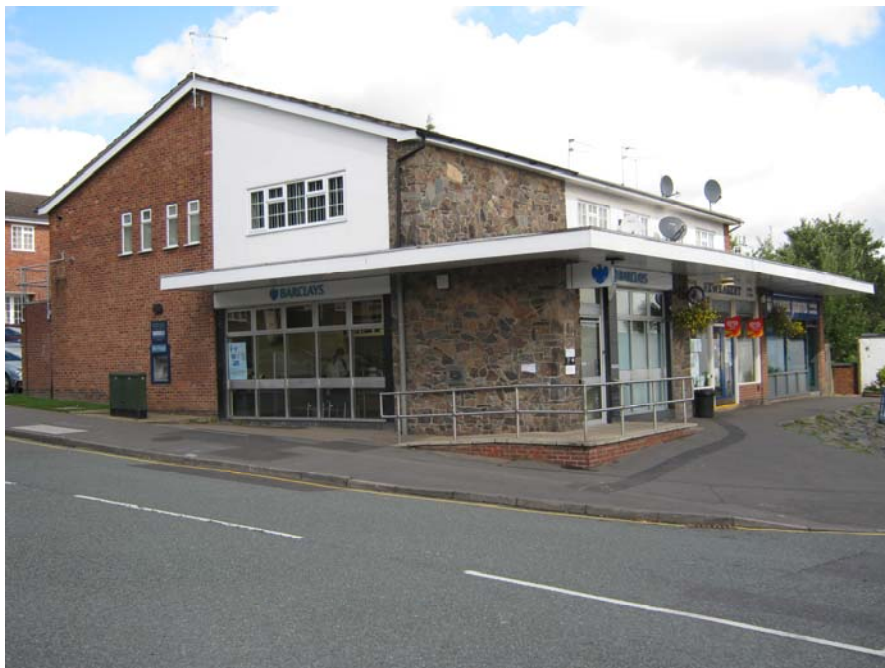
The large shopping development, 24 – 28 Ratby Road, does not respect the traditional character of the conservation area due to its design, use of modern materials and open frontage.

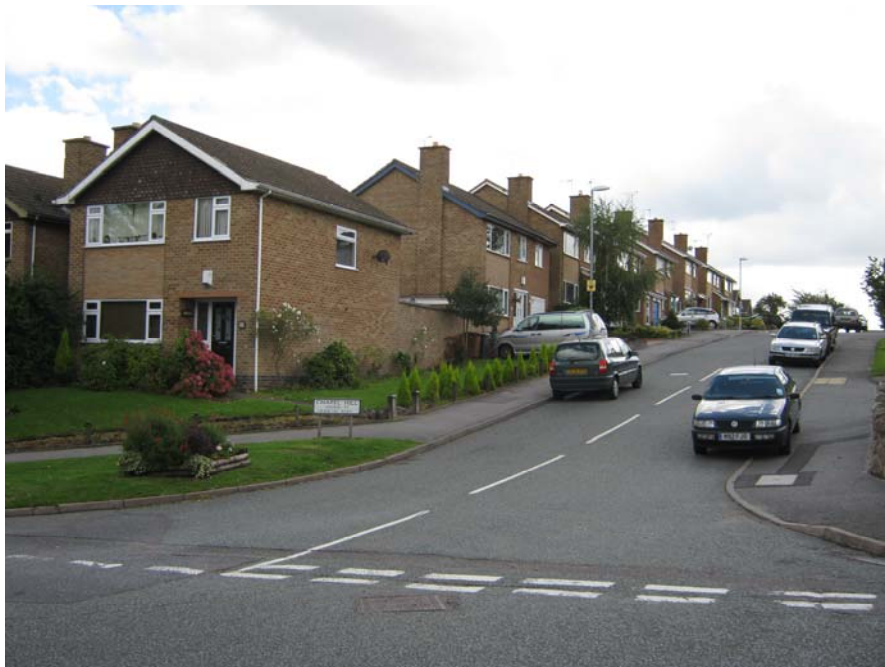
The modern dwellings on Crane Ley Road don't contribute to the character of the conservation area due to their design and materials of construction.

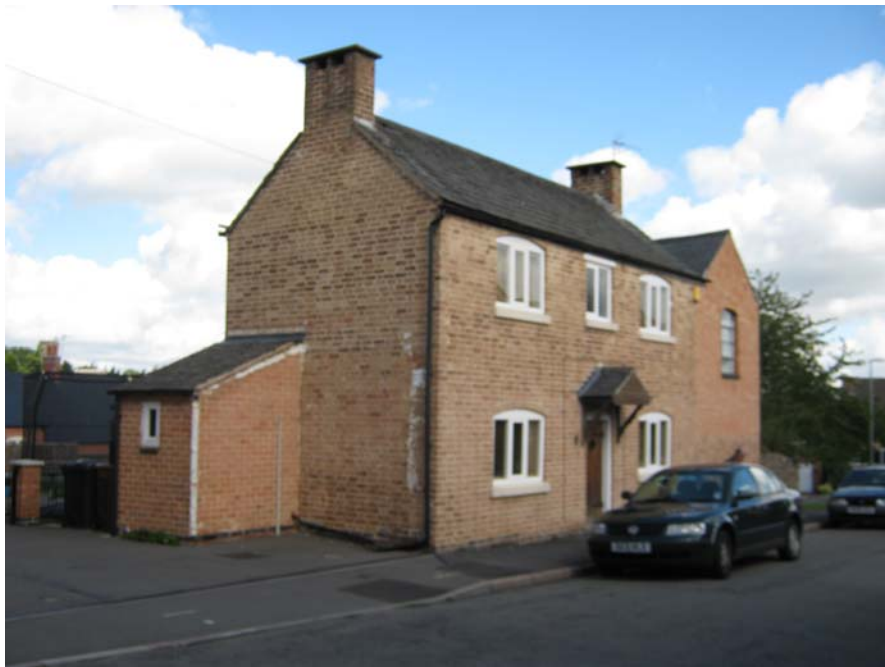
20 Chapel Hill is an early C19 Grade II listed building with a slate roof and two brick stacks. The gable fronting the carriageway has some fine cast iron glazing bar windows. Unfortunately, the property has lost its chimney pots.

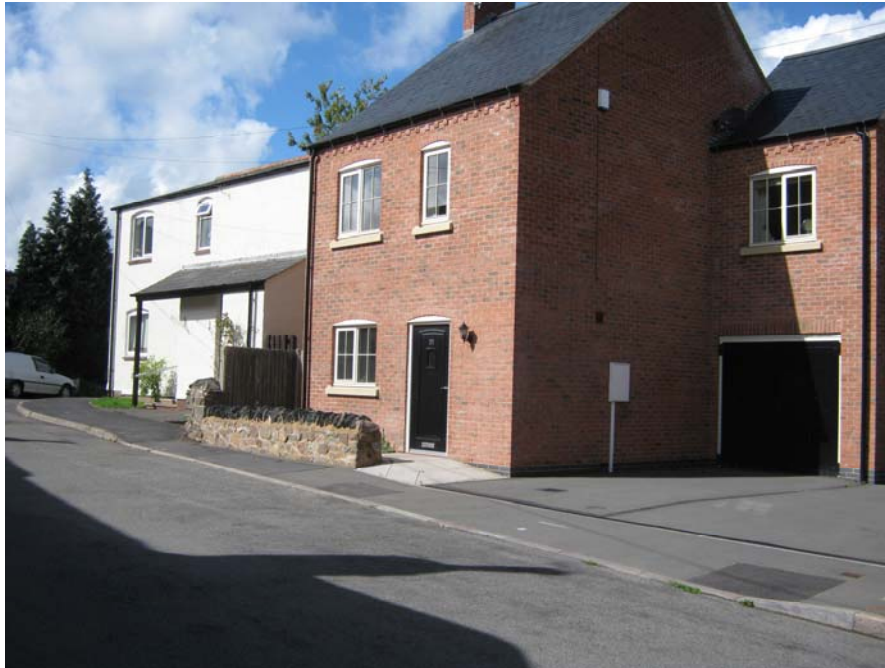
24 Chapel Hill is a modern house built with natural materials, unfortunately, the integral garage is not a traditional feature in the conservation area.

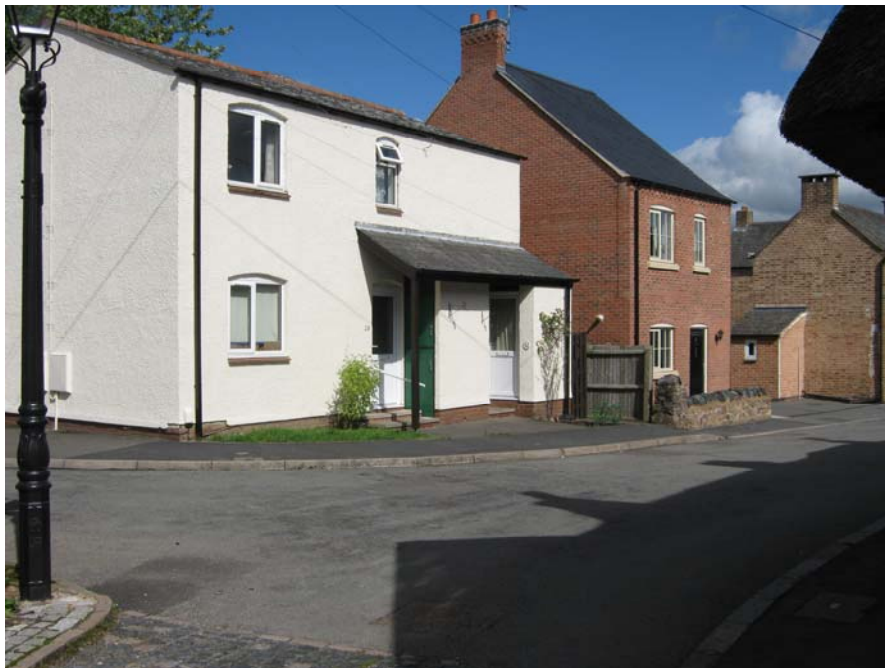
28 Chapel Hill is a modern white rendered dwelling which unfortunately has plastic windows, a front canopy and a shallow roof pitch.

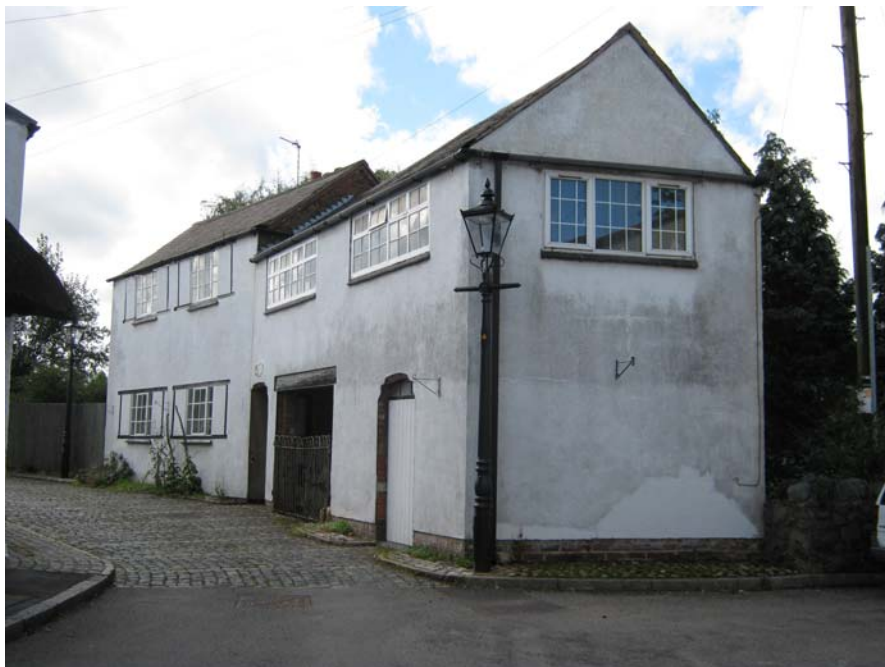
30 Chapel Hill was once a framework knitter's cottage. This is evident from its large rectangular window openings, several of which have now been reduced in size.

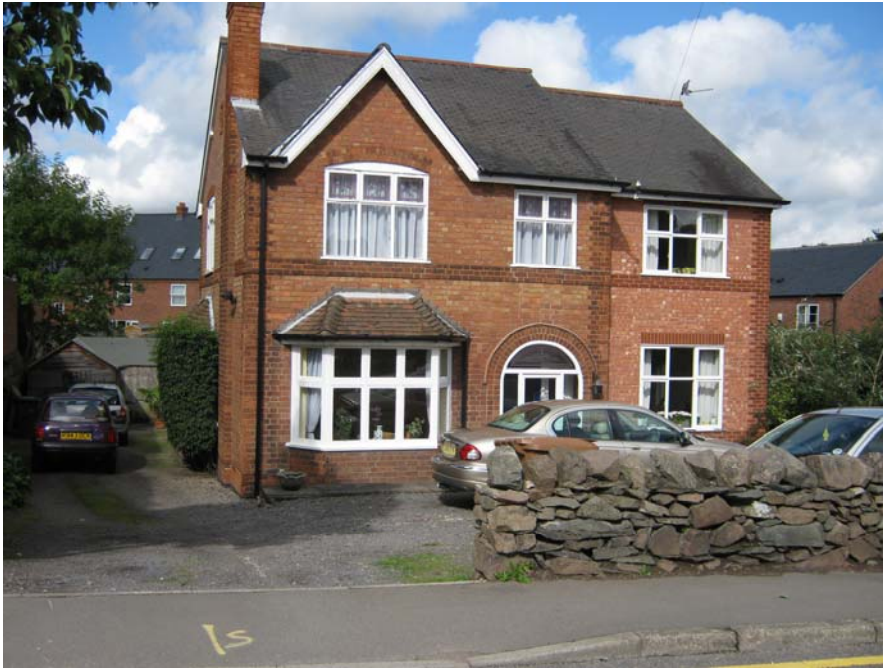
2 Newtown Linford Lane and the adjacent modern housing development do not reflect the character of the conservation area.
